# Best Practice Book for Peatland Restoration and Climate Change Mitigation – Experiences from LIFE Peat Restore Project

The book was prepared and printed with the financial support of the European Commission's LIFE programme within the project "Reduction of CO<sub>2</sub> emissions by restoring degraded peatlands in Northern European Lowland" (LIFE15 CCM/DE/000138, LIFE Peat Restore).

The LIFE Peat Restore project "Reduction of CO<sub>2</sub> Emissions by Restoring Degraded Peatlands in Northern European Lowland" (LIFE15 CCM/DE/000138, 2016–2021) was financed by the European Commission, LIFE subprogramme "Climate change mitigation and adaptation". The project contributed to the mitigation of climate change in different climatic regions (from 52° NL to 59° NL) in the lowlands around the Baltic Sea in five European countries: Germany, Poland, Lithuania, Latvia, and Estonia. The project highlighted the need to pay attention to degraded peatlands and demonstrated restoration as a tool to reduce CO<sub>2</sub> emissions and mitigate climate change, covering 5300 hectares.

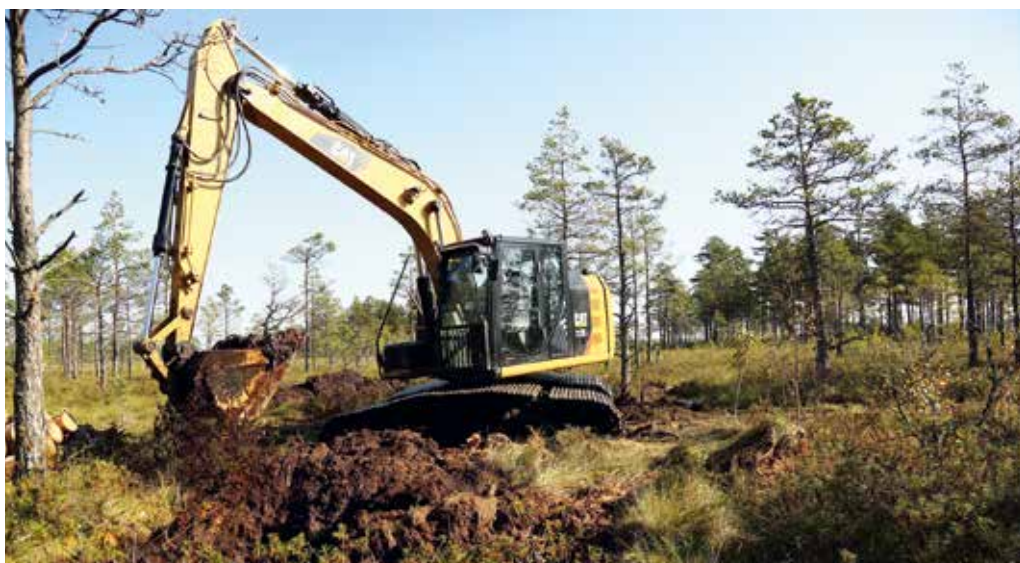
**Figure 2.** Building a peat dam by an excavator. Photo: M. Pakalne.

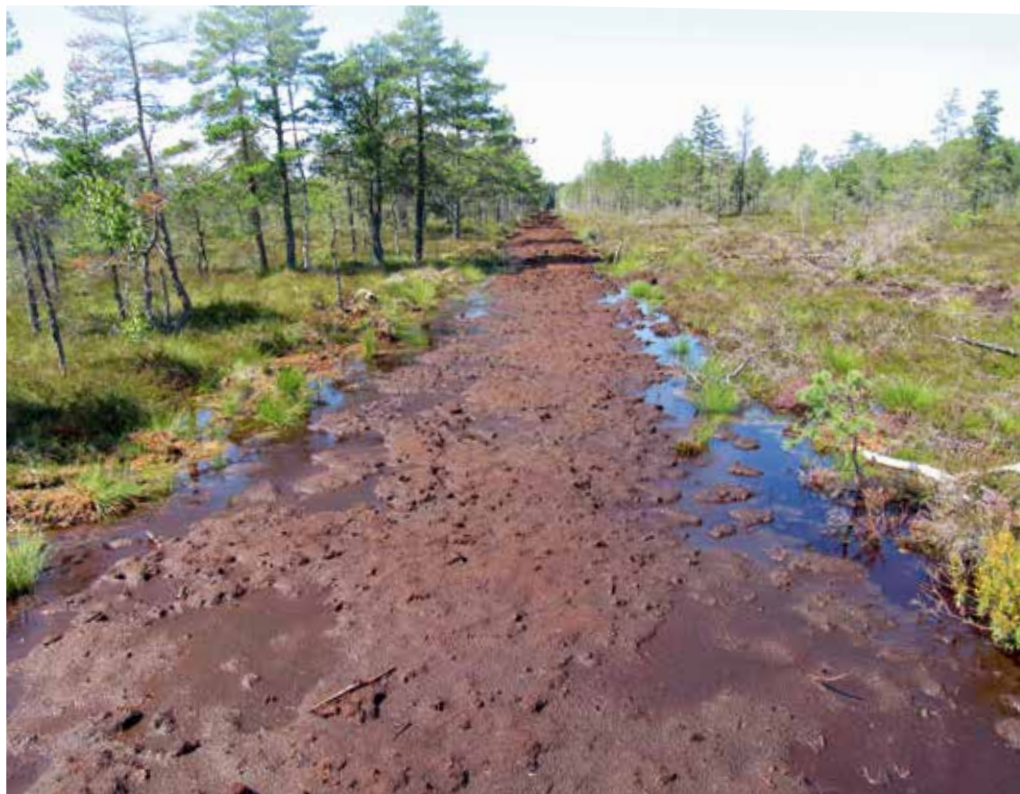
**Figure 3.** A ditch filled up with peat. Photo: A. Priede.

Peatland rewetting by filling the ditches or installing the dams on drainage ditches is a well-approrated and widely applied method in many countries (Figure 2, 3). Different types of dams and other types of constructions may be used: peat, mineral soil, plastic, wooden or composite dams. The ditches may be filled with peat or mineral soil, thus eliminating their effect on peatland. In exceptional cases when the dams or filling of ditches cannot ensure the desired water level, other constructions can be installed, e.g. dikes, sluices, barriers in sloping (inclining) mires or other depending on the site conditions and possibility of the machinery to reach the restoration area.

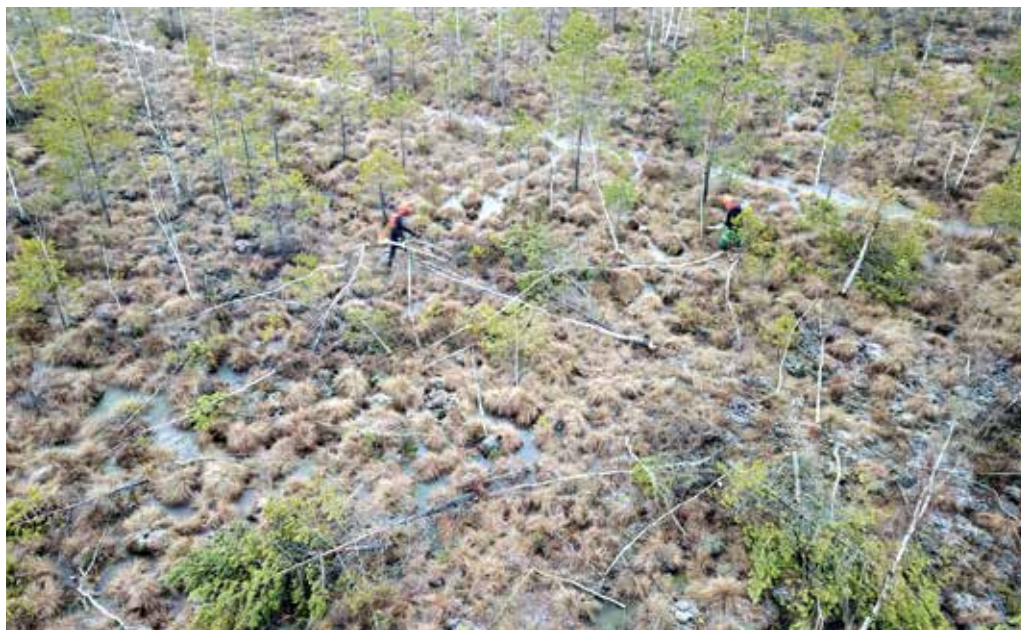
**Figure 4.** *Manual removal of trees in a drained bog before rewetting (Sachara peatland, Lithuania, March 2020). Photo: Ž. Sinkevičius.*

As a part of the LIFE Peat Restore project, special purpose clearings were carried out in the Amalva, Sachara and Pūsčia peatlands (Lithuania, Figure 4). Similar work (clear cutting or thinning) was done in the Polish restoration areas in Słowiński National Park that had been severely damaged by drainage and peat extraction. Partial removal of shrubs and trees to prevent the overgrowth of a fen was carried out in the Engure Lake restoration area in Latvia. In the comparatively less degraded Suursoo-Leidisoo peatland (Estonia) and in the Baltezers and Augstroze peatlands (Latvia), the trees and shrubs were not cleared – it is expected that a certain proportion of the tree will die after rewetting.

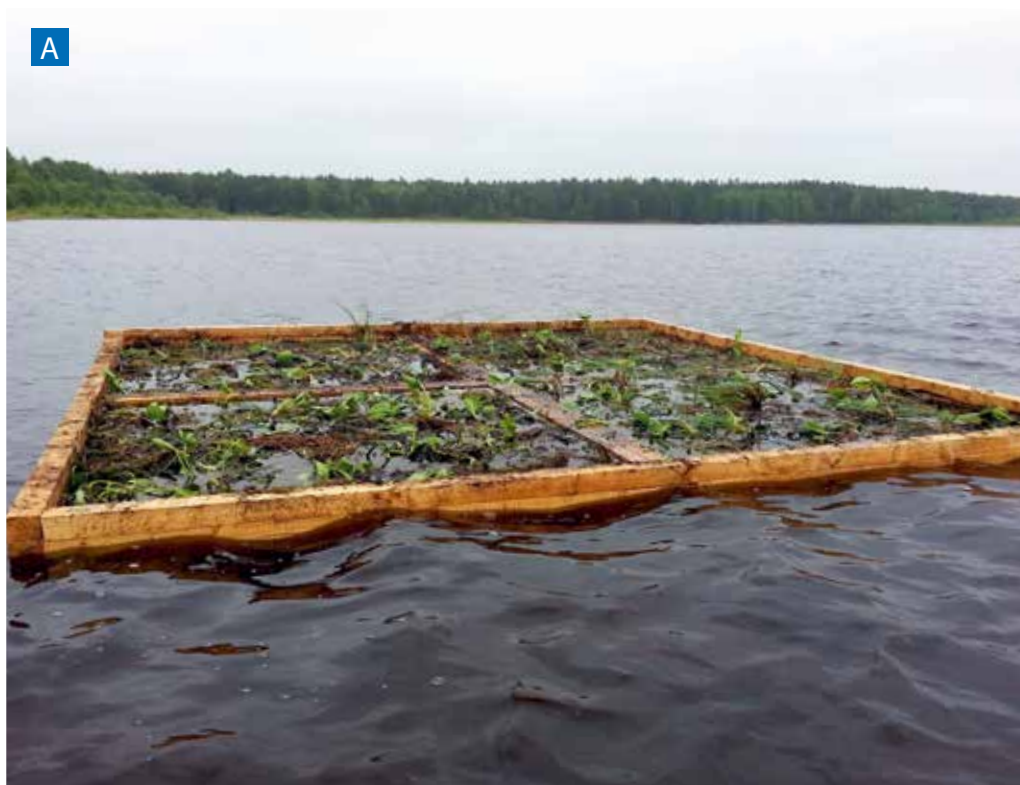
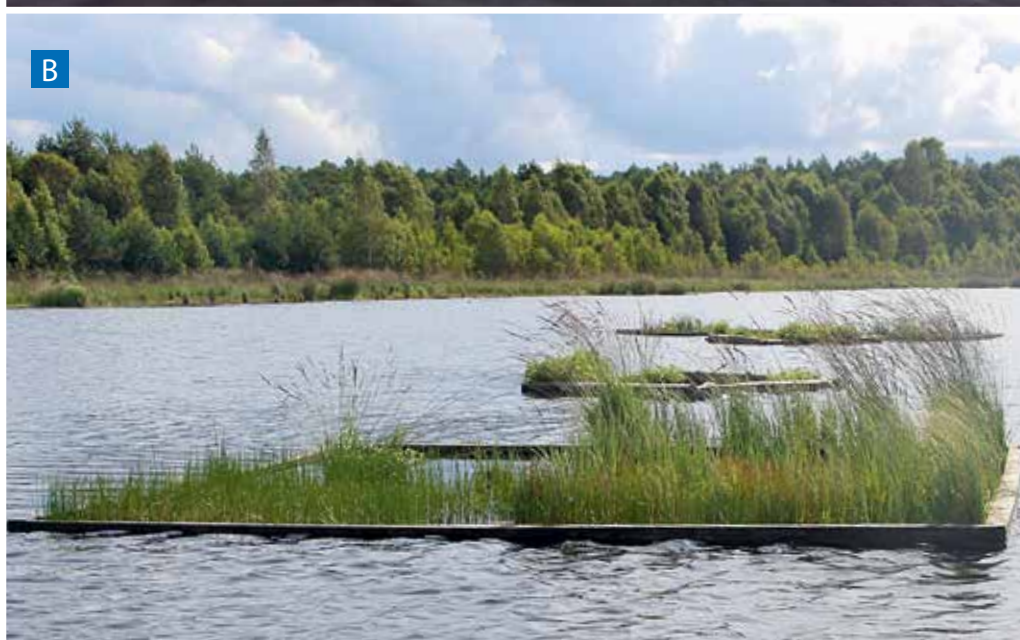
**Figure 7.** *The first island prototype developed during the LIFE Peat Restore project: in May 2017, just after planting the vegetation (A), and two years later, in summer 2019 (B). Poland, Wielkie Bagny. Photos: K. Bociąg.*

The LIFE Peat Restore project team in Poland carried out an experiment in a former peat-extraction water basin, where floating islands based on wooden constructions were anchored to the bottom of the water body and vegetated with the target plant species (Figure 7). It was decided to use natural materials, mostly wood, expanded cork and coconut mats. The constructed floating islands became inhabited by species typical of partly immersed peat communities. In the future, this method may also be used in other flooded post-harvested peatlands and find use in other types of water bodies. Details of the experiment are discussed in *Chapter 4.2.2.*

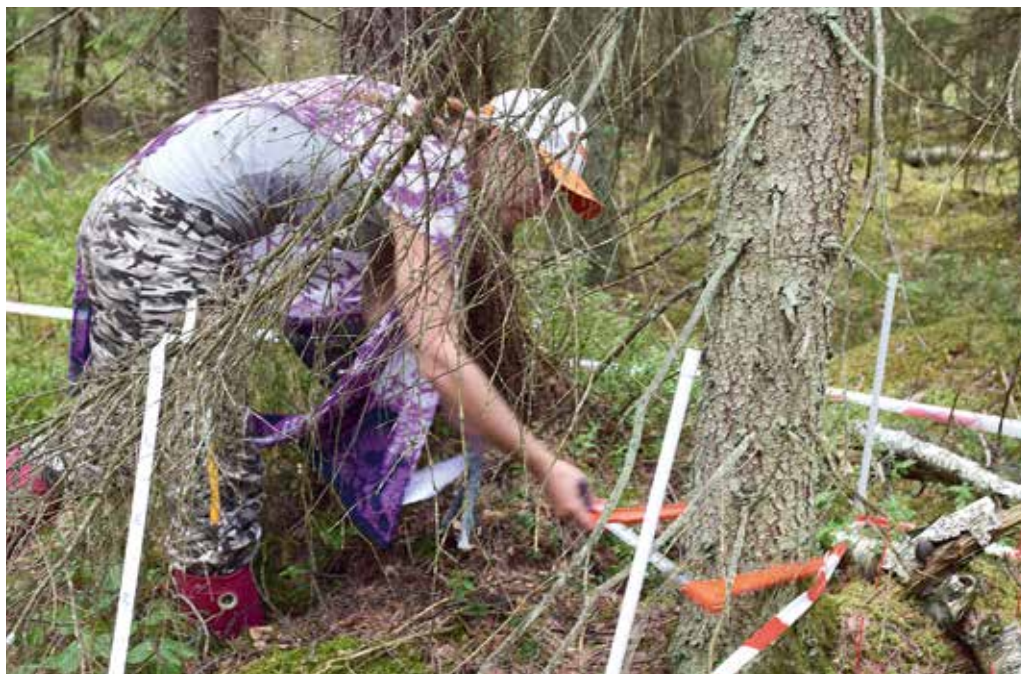
**Figure 8.** *Tree diameter and height measurements in Suursoo-Leidissoo, Estonia. Photo: R. Pajula.*

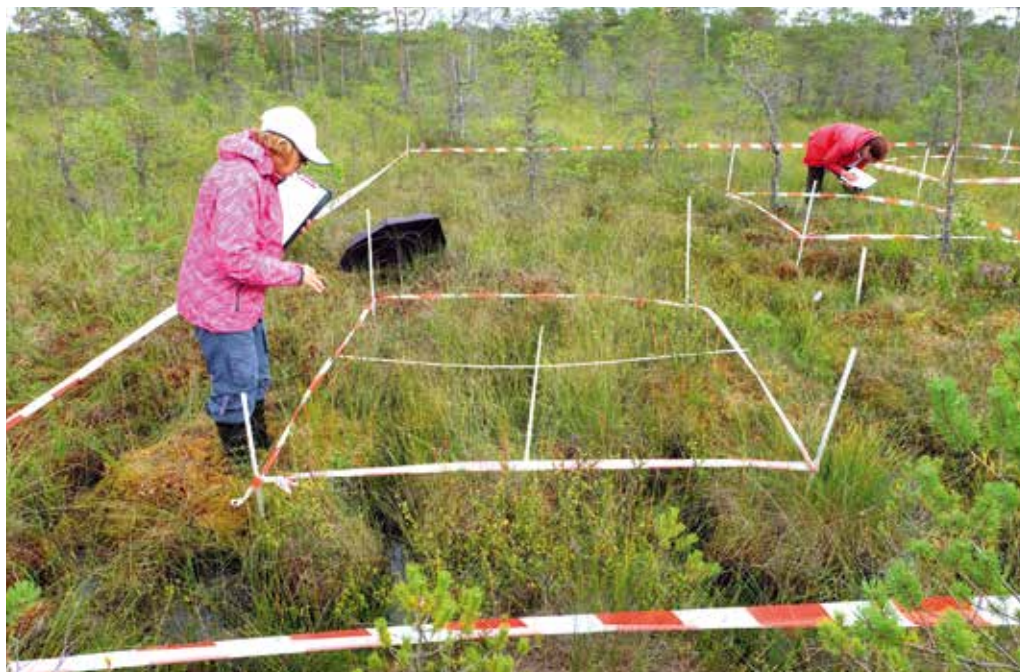
**Figure 9.** *Plant cover estimation in Suursoo-Leidissoo, Estonia. 10 x 10 m monitoring plot with smaller subplots, their borders marked with a tape. Photo: R. Pajula*

The data obtained can be statistically processed before restoration and during the vegetation succession after implementing the restoration measures. In order to monitor the vegetation dynamics, the LIFE Peat Restore team established a monitoring scheme that consists of permanent study plots (10 × 10 m). The number of these plots depends on the size and uniformity/heterogeneity of the area. These plots were used for estimation of trees (species, height, age, diameter; Figure 8), cover of shrubs, plant species composition and cover. Smaller (2 × 2 m or 1 × 1 m) subplots within the 10 × 10 m plot (Figure 9) were used to estimate the herbaceous plant and moss species composition and cover (see also the Estonian example in Chapter 4.1.1).

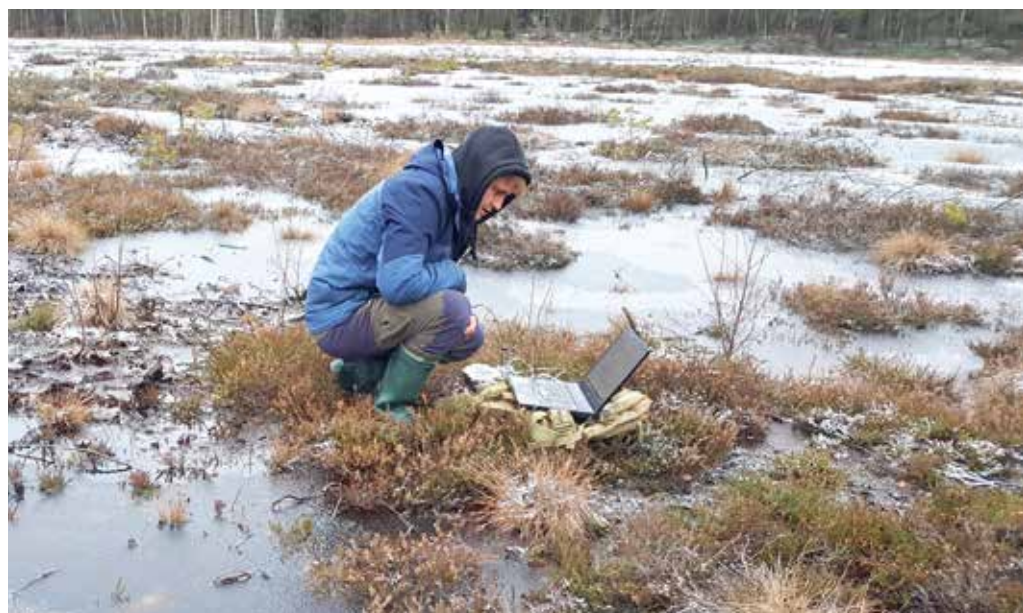
**Figure 10.** Water level monitoring well and the process of downloading the hydrological monitoring data in Sachara peatland (Lithuania). Photo: L. Sendžikaitė

The most appropriate approach is to use automatic loggers for water level monitoring (Figure 10). Data recording frequency of once or twice a day is sufficient for general hydrological monitoring. In the LIFE Peat Restore project, data loggers which register data within a two hours interval were used. Water level observations should be linked not only with rewetting and weather conditions, but are also used in interpreting ecosystem photosynthesis and transpiration in modelling the GHG measurements (see *Chapter 3.6*) results over the whole year.

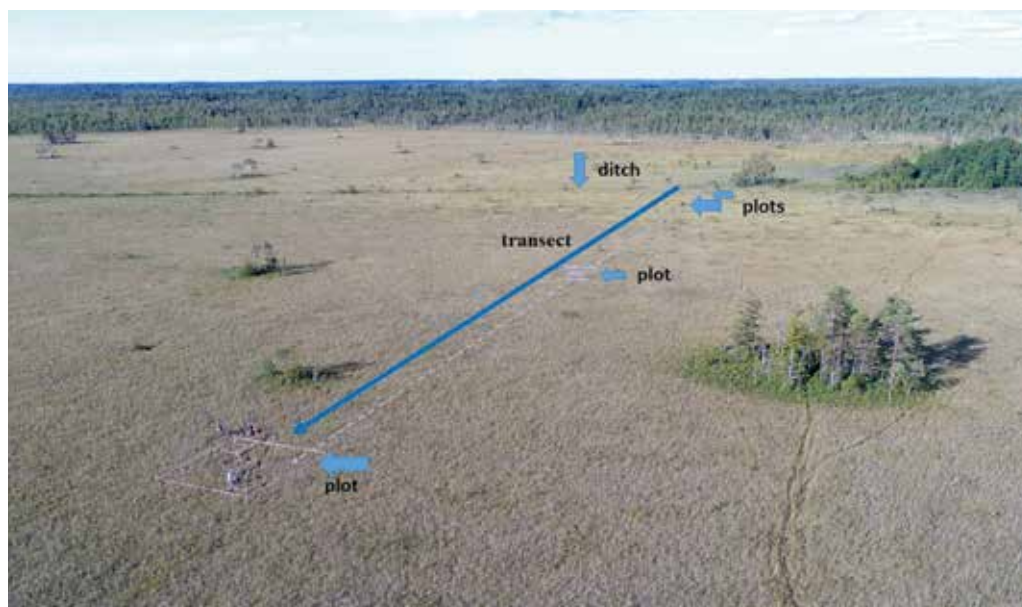
**Figure 16.** Four monitoring plots on a transect that crosses the ditch in the northeastern part of the Suursoo-Leidissoo peatland, the best preserved alkaline fen in the area. Photo: R. Pajula.

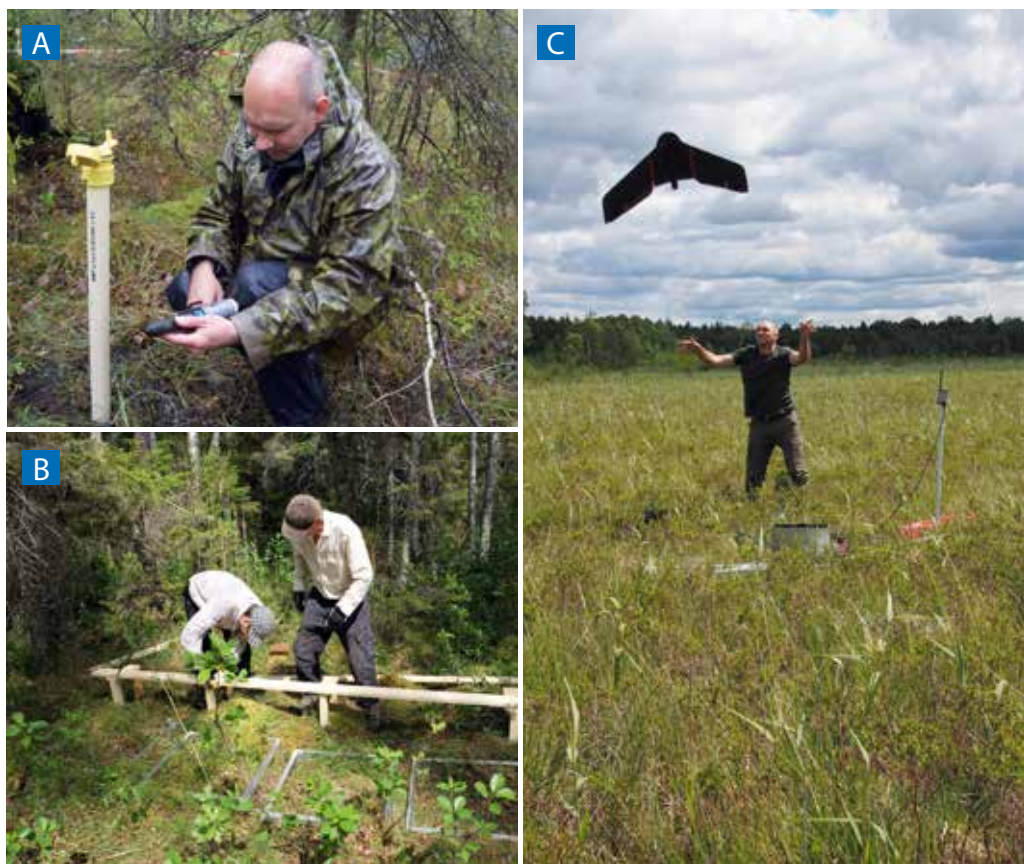
**Figure 18. Some examples of actions in Suursoo-Leidisoo peatland::**

*A – data downloading from the water level logger (photo: L. Truus);*

A water level monitoring system of water level loggers was installed (71 loggers and three piezometric stations) for gathering water level fluctuation data (Figure 18A). Loggers registered data within a two hours interval from June 2018 until December 2021. Water level data were modelled and combined with temperature and precipitation data and clustered with vegetation analyses data (Lode 2020, 2021A, 2021B).

Drone equipped with a multispectral camera (*Sensefly eBee Sequoia*, Figure 18C) was used for mapping of normalised difference vegetation index (NDVI). The camera simultaneously recorded photos in four spectral bands (green, red, near-infrared, red-edge) that allows it to generate multispectral vegetation indices. It was used to quantify the amount of green biomass and the photosynthetic capacity of plant cover. The higher leaf area index (LAI) and photosynthetic capacity, the higher is the carbon sequestration rate to the plant biomass. In case of peatlands, NDVI value reflects the cover of vascular plant vegetation. NDVI maps reflect vegetation patterns and allow estimation of carbon uptake by vegetation.

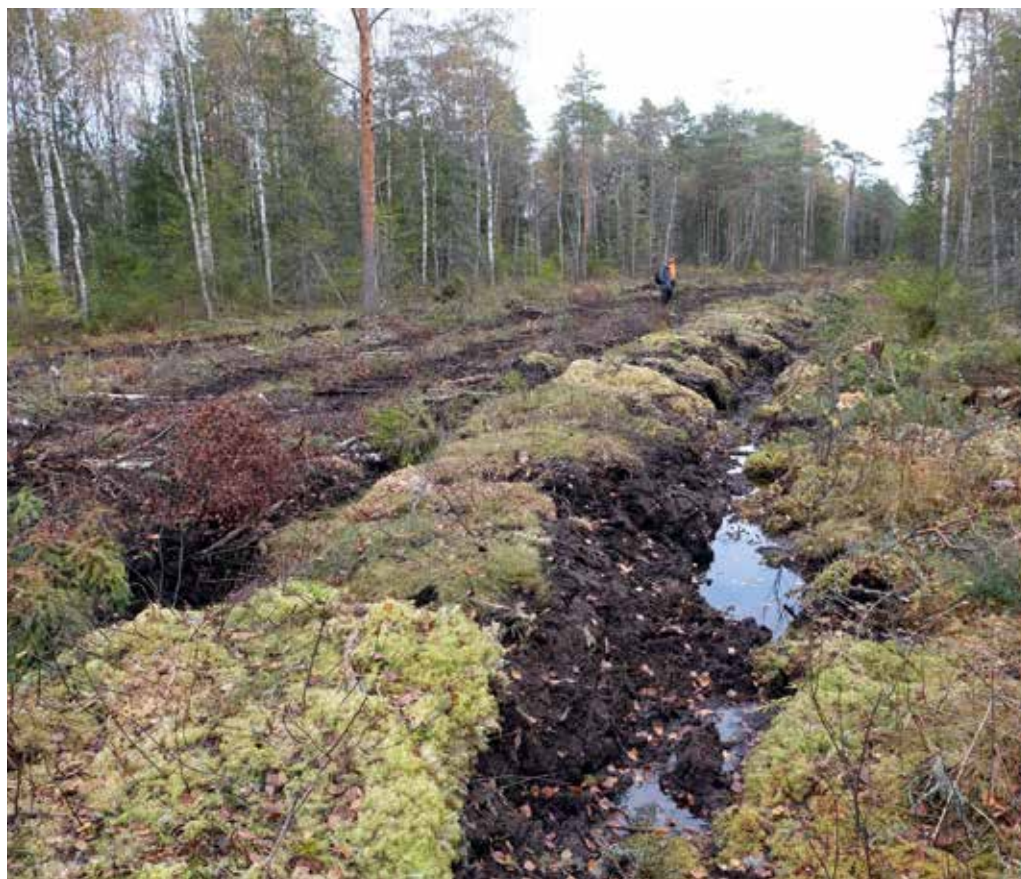
**Figure 22.** A peat dike built along the Kaldemäe stream, autumn 2020. Photo: R. Pajula.

Peat dams and dikes were built from October 2020 to March 2021 (Figure 21–24). Altogether, the technical design envisaged the construction of 173 peat dams and 12.3 km of peat dikes. All construction work was carried out as planned.

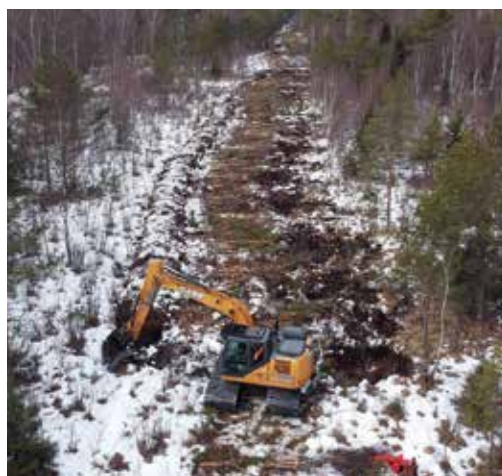
**Figure 23.** Construction of a peat dike running along the Piirsalu stream. Photo: R. Pajula.

The peat used for the construction of peat dams and peat dikes (Figure 23–26) was taken locally from the peat deposit creating holes in the mire surface. The holes were relatively small (2–3 full excavator buckets). More peat was needed to build peat dikes; for this purpose, elongated holes were created (with a maximum size of 5 x 10 m and with a depth up to 1 m). Distance between the holes was kept at least 2 m to prevent the formation of flow channels. The distant slope was designed for sloping 1:1.5 to allow the fallen animals to escape from holes.

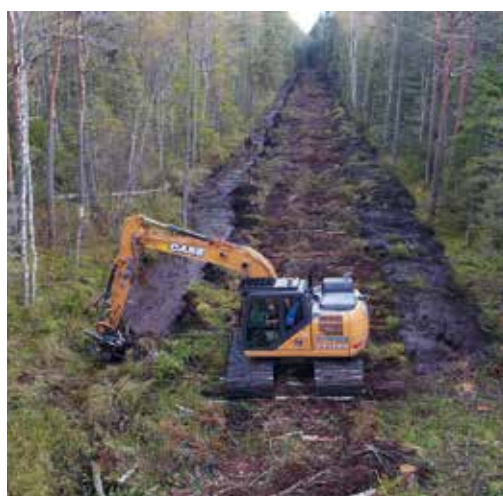
**Figure 24.** Opening of the old bed of Kaldemäe stream for fish migration. Photo: R. Pajula.

To restore the drained areas around the straightened Kaldamäe stream, the ditch was redirected to the old bed, thus opening it for fish migration (Figure 24). Both dikes and dams were well visible in the satellite images (Figure 27B), therefore *Sentinel* satellite images were used to monitor the progress of the work, as the project team could not be present all the time.

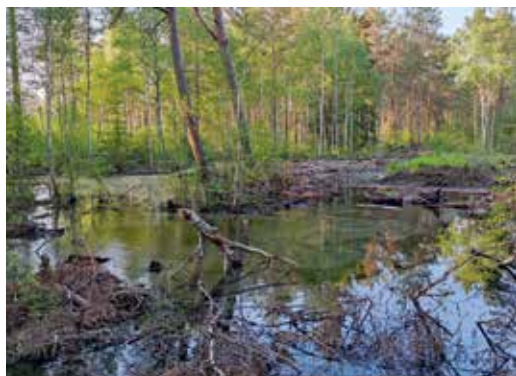
**Figure 25.** Water in the drained peatland forest in May 2021, two months after blocking the ditches. Photo: R. Pajula.

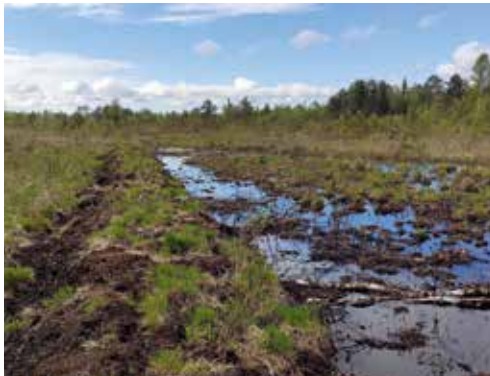
**Figure 26.** Raised water level behind the peat dike running along Piirsalu stream in spring 2021. Photo: R. Pajula.

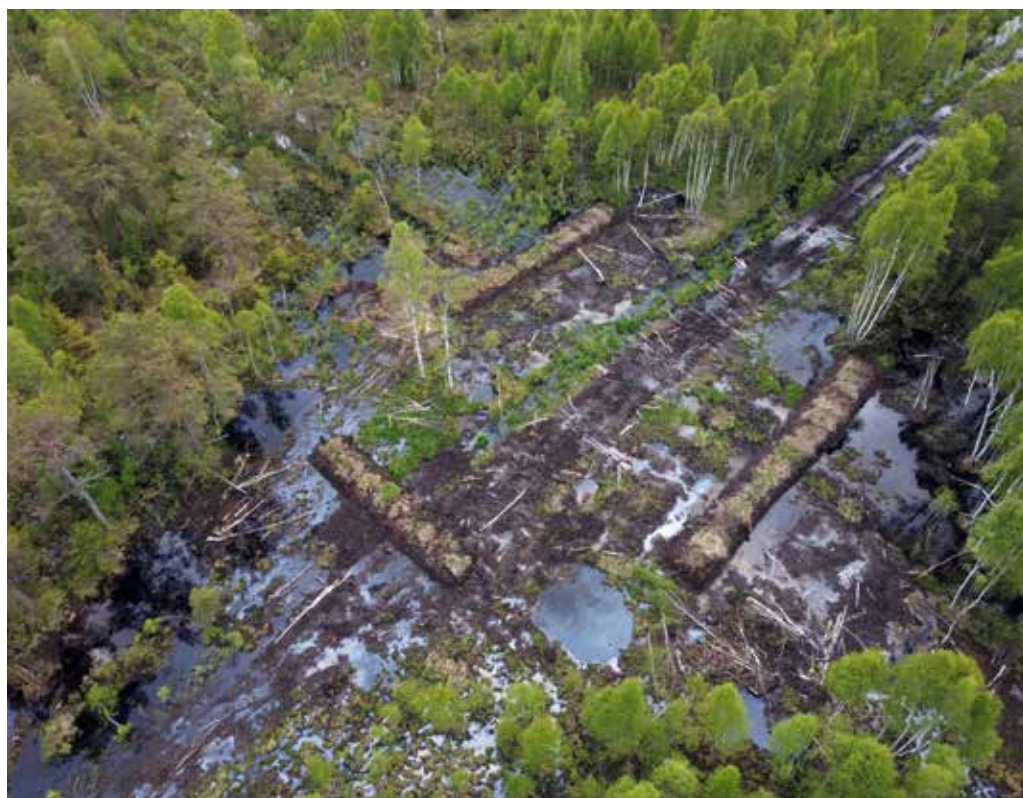
**Figure 29.** Aerial view of the ditch crossing in the eastern part of the Suursoo-Leidisoo restoration site in spring 2021 after the construction of the dams. The small pools are holes where peat was taken for dam building. Photo: R. Pajula.

The first results of the hydrological restoration were indicated by the groundwater level rise just after the dams and dikes were built. One-site surveys and drone monitoring demonstrated that all dams on the ditches and along fish brooks worked well keeping water on the mire surface (Figure 29). It is obvious that the duration of the high water period in spring may last up to the end of June. It is common in fens that in July the water table drops down. Importantly, the high water table (even overflow) should not stop earlier; before restoration measures, the water level dropped down already in May (Figure 30).

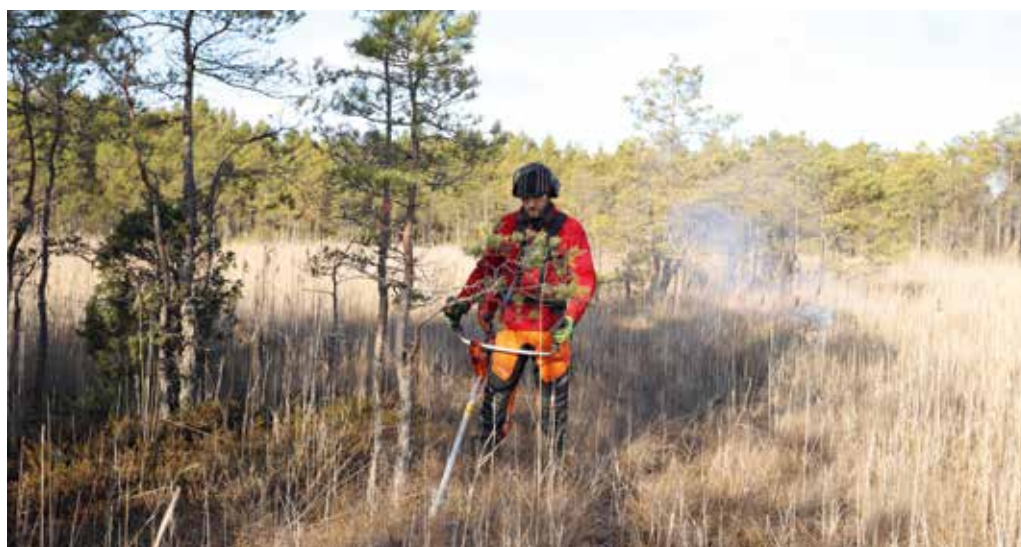
**Figure 40.** Clearing of shrubs in the Engure fen was done manually using a brushcutter (February 2020). Photo: K. Libaurs

In the Engure Lake peatland, cutting of trees and shrubs (23.1 ha) was selective (Figure 40). Older pines, groups of pines and healthy junipers were preserved, as they serve as important biodiversity and landscape elements (Figure 42). As agreed with the land manager, trees with a diameter above 12 cm may not be removed, which was strictly followed. The young trees and shrubs were cut using hand tools (chainsaw, brush cutter), collected in heaps and burned on

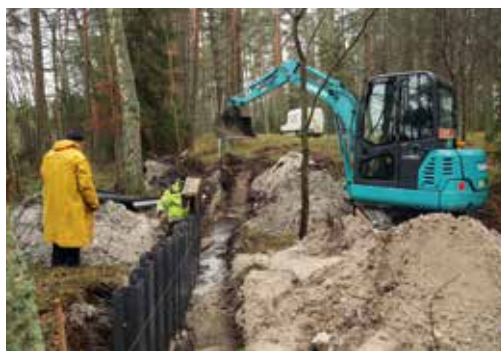
**Figure 43.** *Installing the plastic piling in the Engure restoration area. Photo: M. Pakalne.*

Two plastic piling dams were installed on the shallow ditches where a rapid runoff of water from the fen to the lake was observed. Thus, it was decided in the very early stage of the project that blocking the ditches may help to retain the water and to improve the water regime in the fen. The location of ditches was different from most situations in peatland restoration areas (often difficult to access), as here it was possible to access the ditches by machinery (forest road on stable mineral soil,

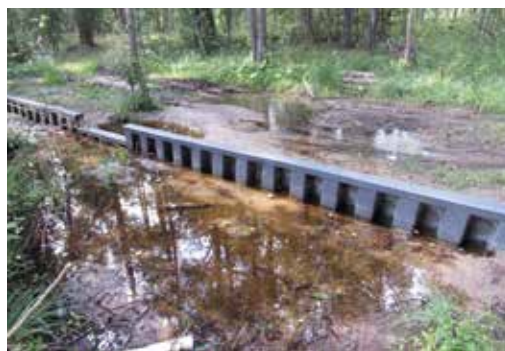
**Figure 44.** *Plastic dam in the Engure restoration area in August 2021, more than half a year after building. Photo: A. Priede.*

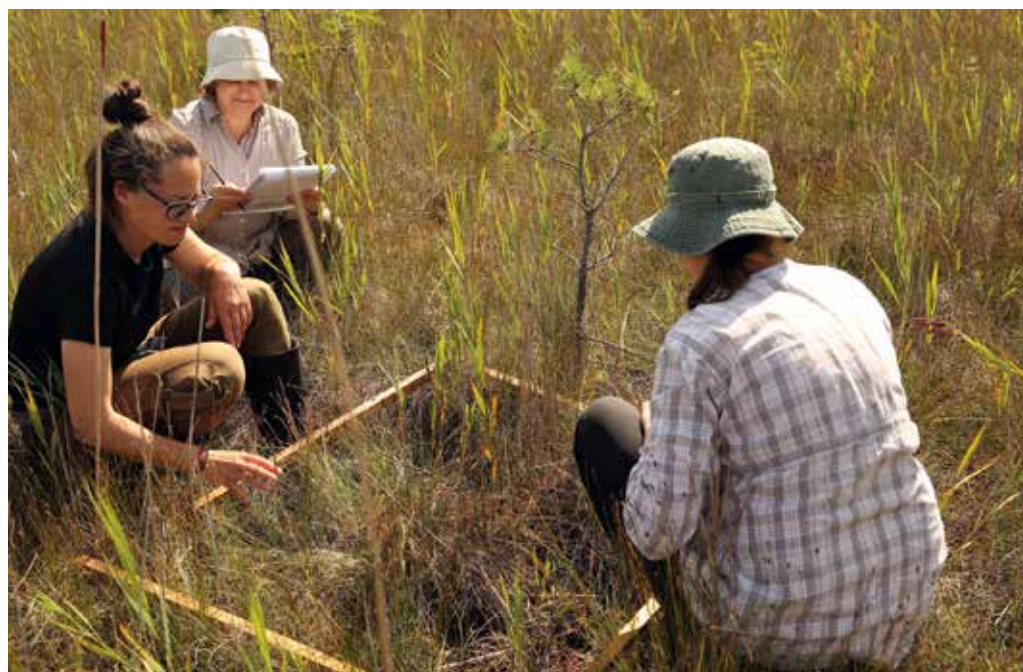
**Figure 45 .** *Vegetation monitoring in Engure peatland. Photo: K. Libauers.*

Vegetation monitoring (Figure 45) in permanent plots was carried out every year during the summer season since 2018 according to the joint methodology agreed among the project partners (see *Chapter 3.2*). In Engure, three large plots (10 x 10 m) and 30 subplots (1 x 1 m) were established. The first monitoring results suggest that after removal of shrubs and trees, there is a positive effect on the plant cover, giving more space for the mire vegetation to develop. It also favours the growth of orchid species, such as *Liparis loeselii*. Still, the vegetation development greatly depends on the water level fluctuation during the vegetation period as dry periods interchange with flooded bryophyte layer after heavy rainfalls. As in the monitoring area, the water level has not been raised by building of dams, substantial changes in the plant cover have not been

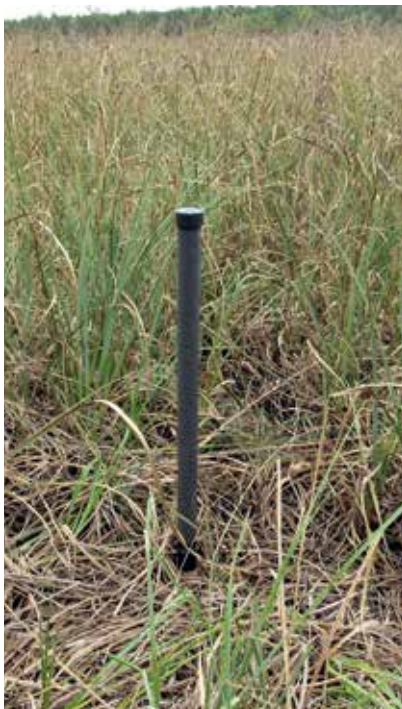
**Figure 47 .** Water level monitoring well. Photo: A. Priede.

To assess the restoration success, during the planning stage (in 2018), vegetation monitoring plots and water table monitoring wells (Figure 47) were established (the map depicting the location of monitoring points is given in Figure 46).

Water table monitoring wells equipped with automatic data loggers were installed in April 2018, more than two years before installing the dams (building was completed in November 2020). Water table was automatically measured by loggers once per hour (except for the periods when the shallow groundwater was frozen).

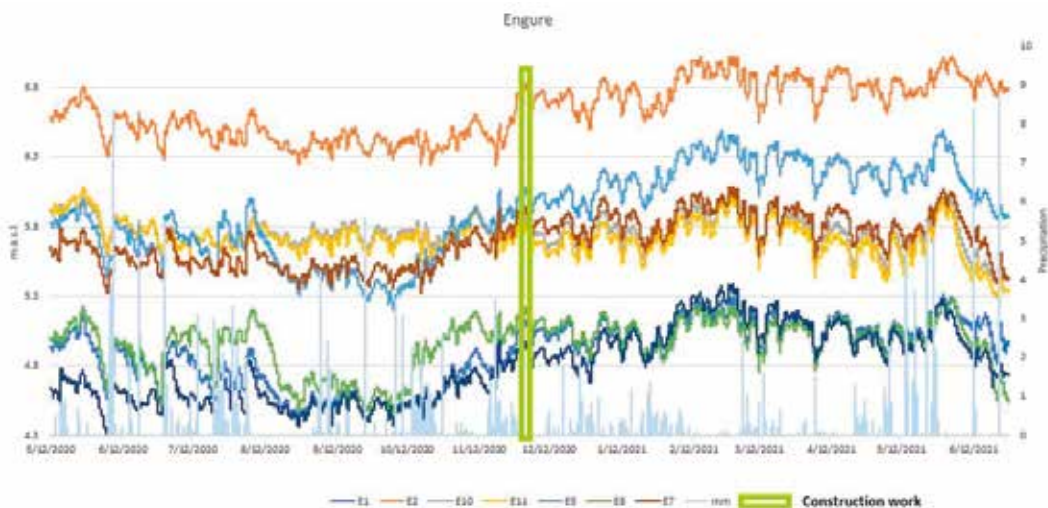
**Figure 48.** Water level fluctuations in the Engure restoration area (the water level is presented above the sea level), from December 2020 to June 2021. In 2020, improvements were made to the measurement system with additional equipment that displays more accurate and reliable data, therefore only this period is presented here.

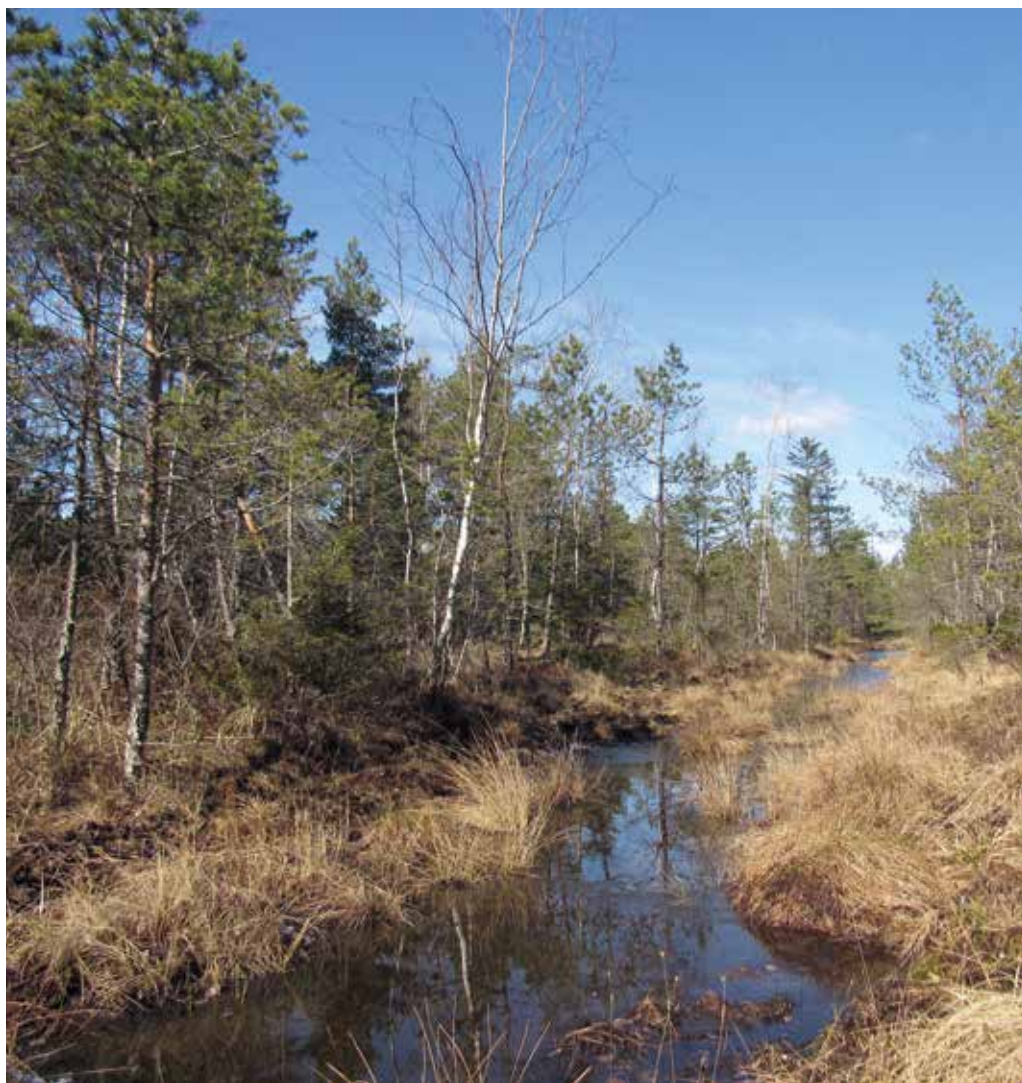
**Figure 50 .** *Drainage ditch in Baltezers peatland before rewetting. Photo: A. Priede.*

During the first period of Latvia's independence (1918–1940), a national scale peat extraction propaganda encouraged farmers to cut peat for soil improvement, bedding and heating. Apparently, such intentions also affected Baltezers peatland. At that time, the peatland was partly drained and prepared for peat cutting in an approximately 30 ha large area. Drainage works included digging of ditches and establishment of roads to transport the peat. Peat extraction in this area has not commenced, at least not in large amounts. The impact is still in place as ditches (Figure 50) and old, highly decomposed piles of peat.

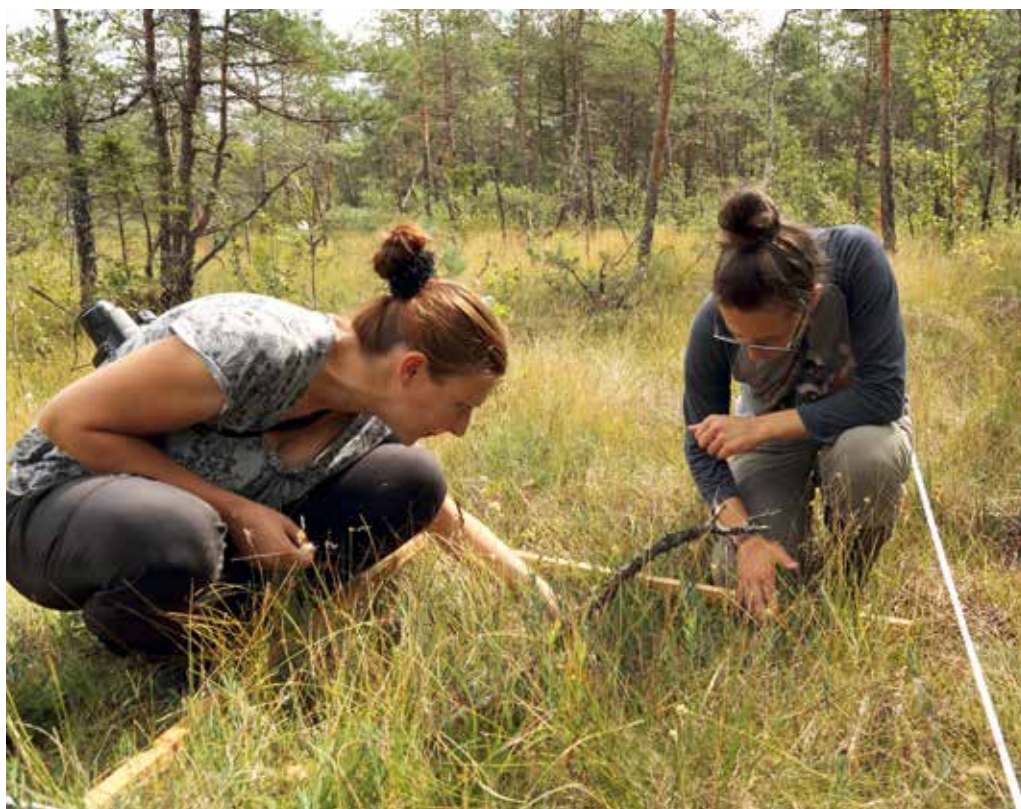
**Figure 53 .** *Vegetation monitoring in Baltezers Mire was carried out by experienced experts.*  
*Photo: M. Pakalne.*

During the planning stage, vegetation monitoring plots and water level monitoring wells were established (Figure 52). The vegetation and water level monitoring was commenced two years before restoration, in 2018. Vegetation monitoring (Figure 53) in permanent plots was carried out every year during the summer season according to the joint methodology agreed among the project team (see *Chapter 3.2*). In Baltezers Mire, three large plots (10 x 10 m) and 30 subplots (1 x 1 m) were established.

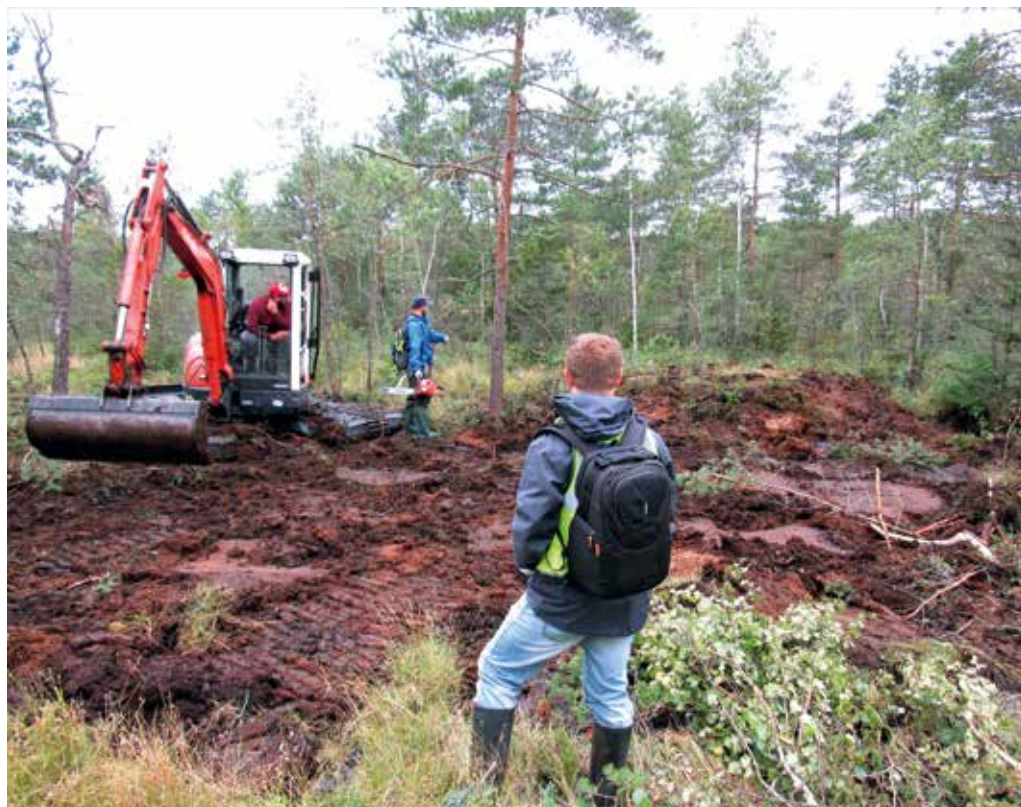
**Figure 54 .** Dam building process in Baltezers Mire. Photo: A. Priede.

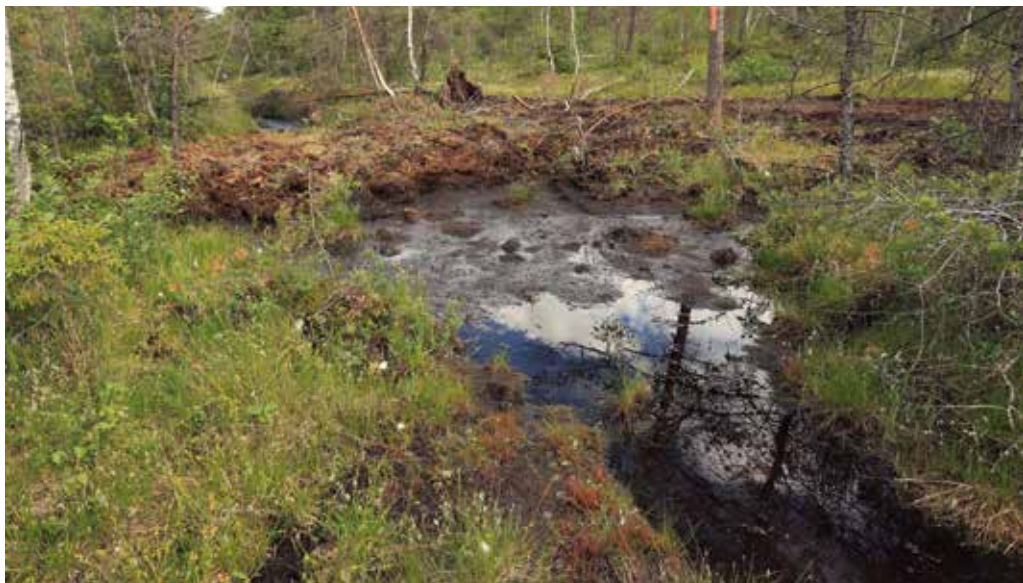
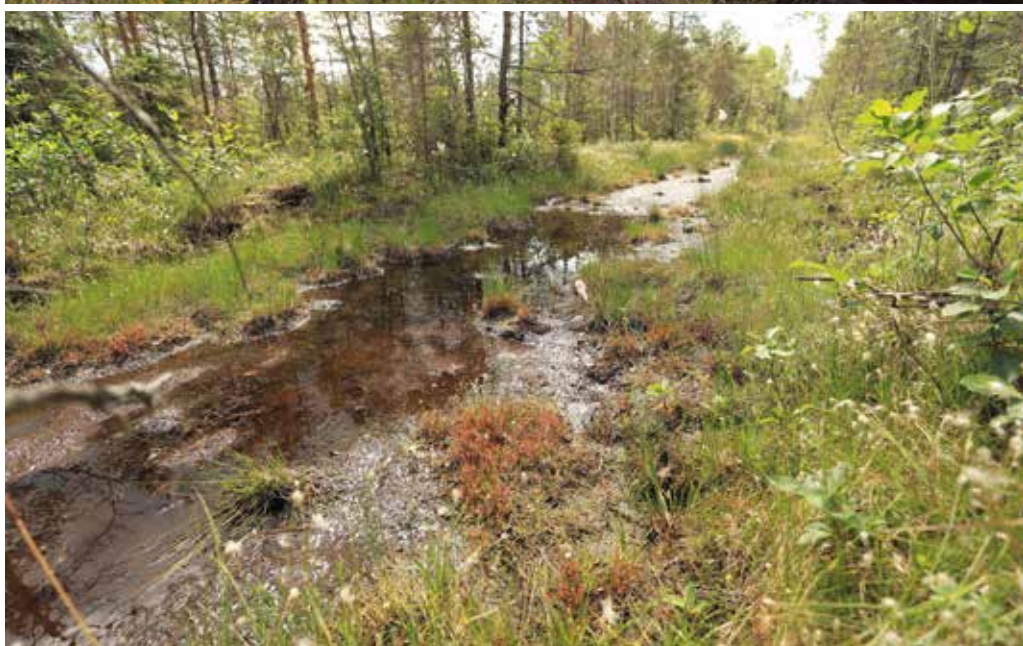
**Figure 55** . Accumulation of water in ditches between the peat dams, June 2021. Photos: M. Pakalne.

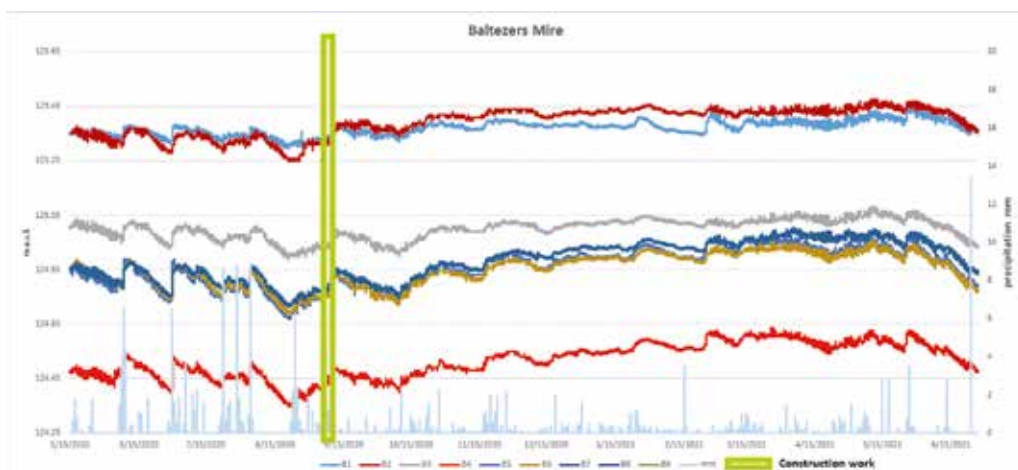
**Figure 56 .** Water level fluctuations in Baltezers peatland before and after the building of dams. In 2020, improvements were made to the measurement system with additional equipment that displays more accurate and reliable data, therefore only this period is presented here.

After building dams, a rise in water levels and stagnation in water flows in the ditches upstream from the dams were observed (Figure 55). The main task of the dams has been achieved: the water is retained in the mire and, in a longer time, will stabilise, i.e. the average water table has risen and the well-pronounced fluctuations, as before rewetting, were becoming smooth (Figure 56).

The lowest groundwater level during the monitoring period was observed in the well B2 installed close to one of the ditches – 42 cm below the mire surface. As a result of rewetting, it reached 11 cm below the surface in the first half of 2021 (the stabilisation to be further observed). The intensity of precipitation after the dam construction also helped to reach the desired water level faster. In the first half of 2021, precipitation was significantly higher than in the same period of 2020. The highest precipitation was observed in May 2021 (39.6 mm) and June (34 mm).

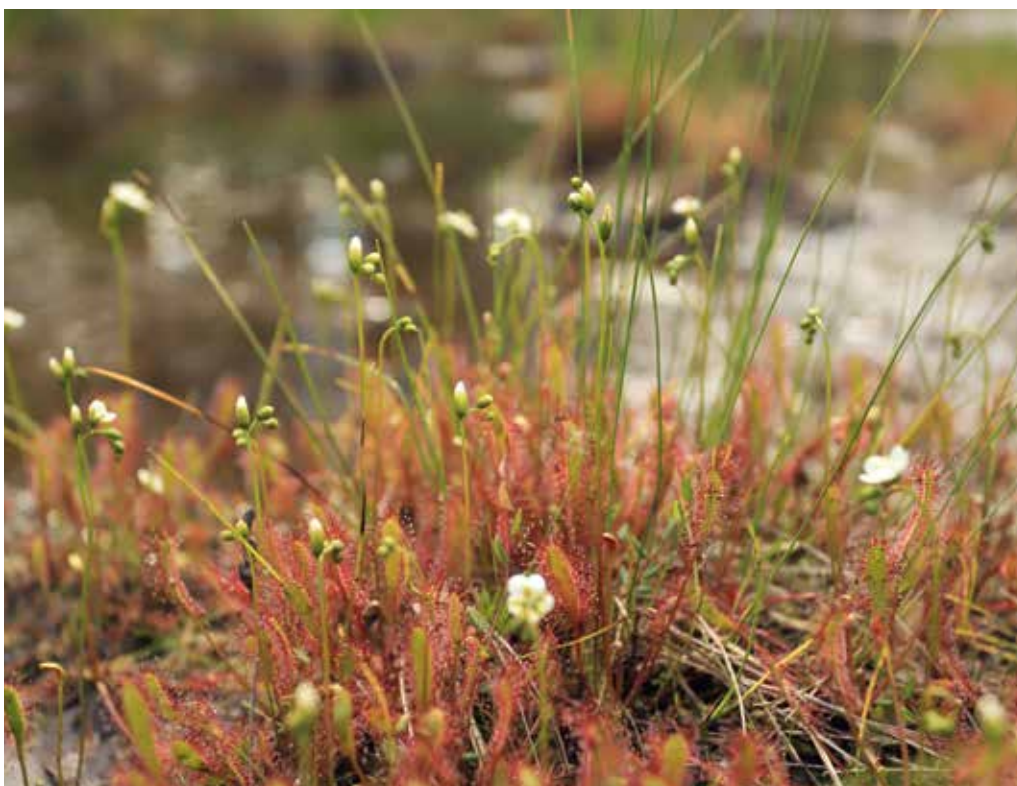
**Figure 57 .** In the early stage after the dam building, the drainage ditches in Baltezers peatland were gradually overgrowing with *Drosera anglica*. Photo: M. Pakalne.

After building dams on the drainage ditches in Baltezers Mire, it was observed the area near the ditches is becoming wetter indicating that the conditions suitable for peat formation are re-established, followed by reappearing of mire species (e.g. *Drosera* sp.) in the drained areas (Figure 57).

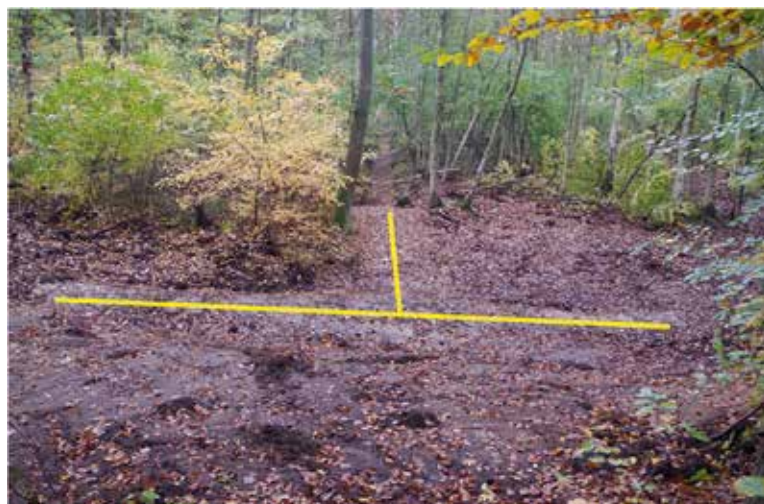
**Figure 66.**

*In the main direction of the water flow, the end of the BB-3's central drainage ditch and a T-shaped "catchment ditch" were filled with clay up to a depth of 2 m (October 2020). Photo: J. Etzold.*

In the small kettlehole peatland BB-3, both ends of the central drainage ditch penetrating the sealing layer were closed with clay brought into a trench of 2 m depth (Figures 65, 66). The clay was transported from an artificial soil filling from a distance of less than 5 km away. In contrast to the simple clay filling of the upper 10 m of the ditch, the end in direction of the water flow received additionally a "catchment ditch" rectangular to the ditch forming together a "T-shaped" clay-filling (Figure 66).
