# Best Practice Book for Peatland Restoration and Climate Change Mitigation – Experiences from LIFE Peat Restore Project

The book was prepared and printed with the financial support of the European Commission's LIFE programme within the project "Reduction of CO<sub>2</sub> emissions by restoring degraded peatlands in Northern European Lowland" (LIFE15 CCM/DE/000138, LIFE Peat Restore).

The LIFE Peat Restore project "Reduction of CO<sub>2</sub> Emissions by Restoring Degraded Peatlands in Northern European Lowland" (LIFE15 CCM/DE/000138, 2016–2021) was financed by the European Commission, LIFE subprogramme "Climate change mitigation and adaptation". The project contributed to the mitigation of climate change in different climatic regions (from 52° NL to 59° NL) in the lowlands around the Baltic Sea in five European countries: Germany, Poland, Lithuania, Latvia, and Estonia. The project highlighted the need to pay attention to degraded peatlands and demonstrated restoration as a tool to reduce CO<sub>2</sub> emissions and mitigate climate change, covering 5300 hectares.

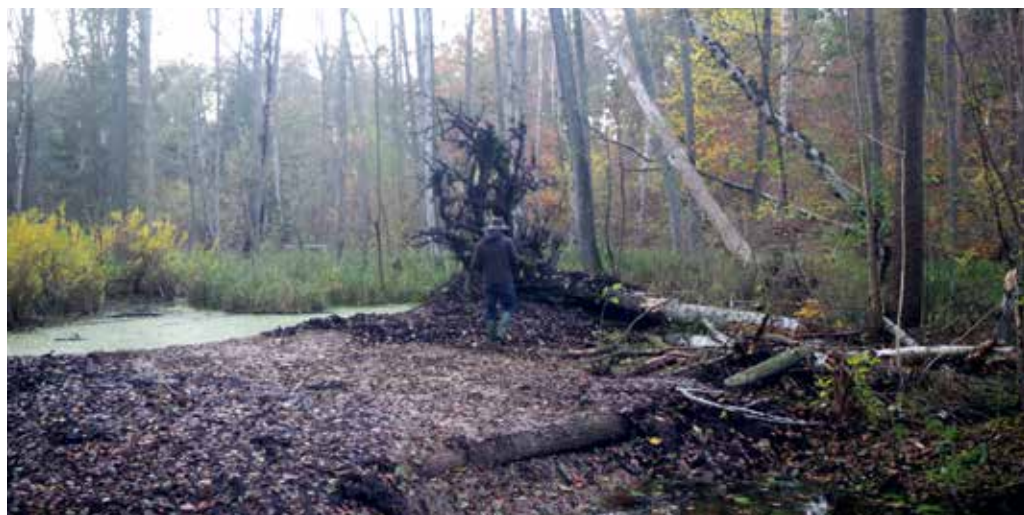
**Figure 67.** *One of the two dams made of clay and trunks blocking the Plötzenseefließ (BB-2), October 2020. Photo: J. Etzold.*

In the BB-2 area, the Plötzenseefließ artificial watercourse draining a 3.5 ha large former terrestrialisation mire with a black alder carr was around 3 m wide. Here, distributed over a stretch of ca. 260 m, five dams were constructed. Each has a length of around 10 m and a width of over 4 m (differing only in their dimensions from the general technical design in Figure 62). At both ends, logs of up to 7 m length cut in the nearest surroundings were placed orthogonally to the ditch to stabilise the filling material. Due to a more pronounced slope, for the two uppermost ditch fillings clay transported to the site was used (Figure 67). The material for the three lower dams was besides wood locally gathered degraded peat from shallow peat diggings .

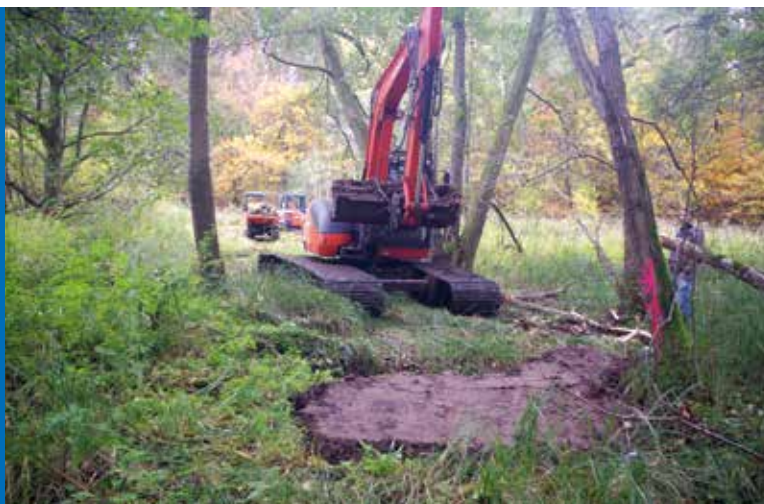
**Figure 68.**

*The excavator starts with the filling of a ditch at the margins of the Pfauenfließ peatland BB-1 (October 2020). Photo: J. Etzold.*

The central parts of the BB-1 area were wetter than expected by the initially contracted company using an 8 t excavator. Despite its low soil pressure of only 150 g/cm<sup>2</sup>, as it was equipped with wide bucket chains (Figure 68), the company did not dare to finalize the rewetting measures at this site. Another specialised company continued the restoration work at the beginning of 2021 with better adapted machinery, a small excavator (1.7 t) driving where necessary on wooden pallets (Figure 69). The work was eased by the winter conditions with frozen soil.

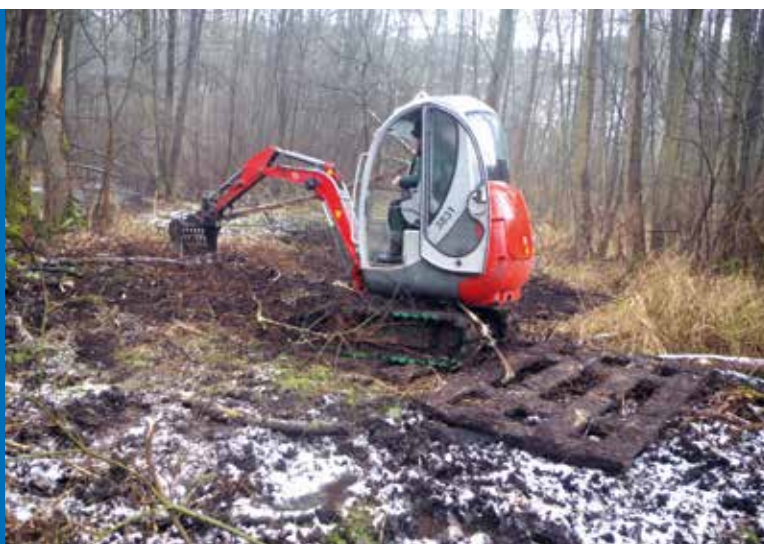
**Figure 69.**

*A small excavator driving on pallets was used in the BB-1 area. This type of vehicle used logs, branches, mineral soil and peat to close ditches flowing into the Pfauenfließ River and the two other adjacent rivers (February 2021). Photo: J. Etzold.*

At more than 20 locations, the ditches in the central and northern part of the restoration area draining into the Pfauenfließ River and the two other adjacent rivers (Figures 61, 69) were blocked by wood and peat constructions.

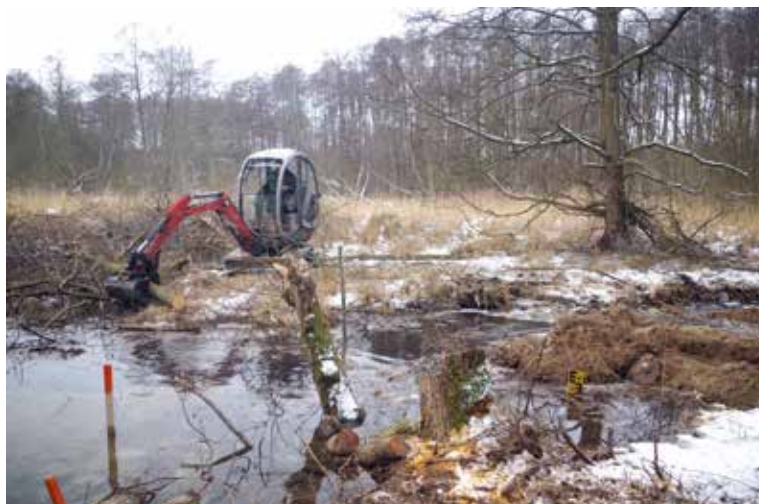
**Figure 70.**

*The excavator installing the so-called bottom glide shortly before the mouth of the Pfauenfließ into river Finow; woody materials, mineral soil and peat was used (February 2021). Photo: J. Etzold.*

Furthermore, for raising the water level in the Pfauenfließ River and in the peatland upstream, the construction works had to preserve the ecologically important continuity of a natural watercourse, i.e. dams could not be built on the natural stream. Near the mouth of the Pfauenfließ River, before entering the Finow River, a 60 m long so-called bottom glide was constructed in order to raise its water level. For this purpose, logs were installed transversely as steps at a defined height and the spaces in between were filled with branches, peat and mineral soil (Figures 70–71).

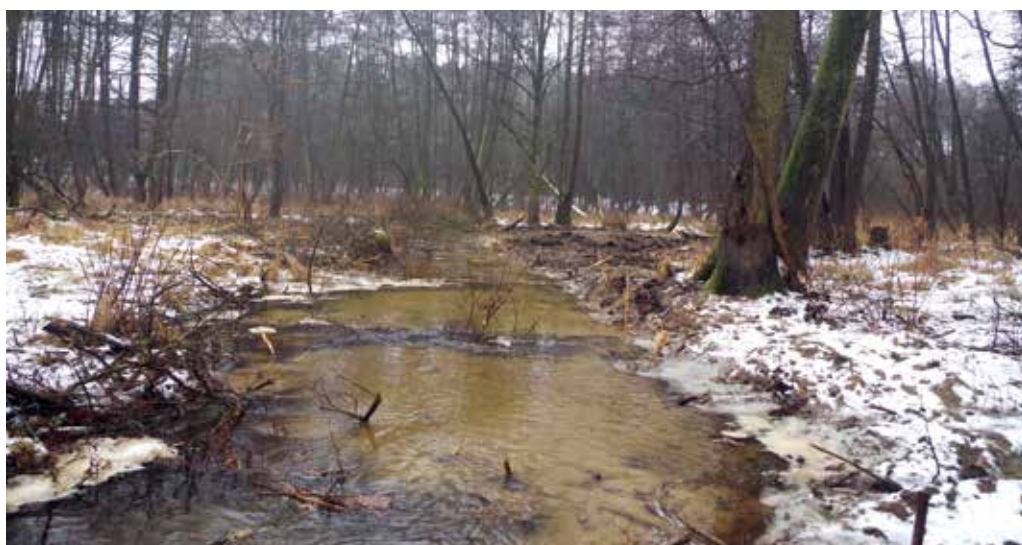
**Figure 71.** *A view downstream along the bottom glide (work completed, February 2021).*

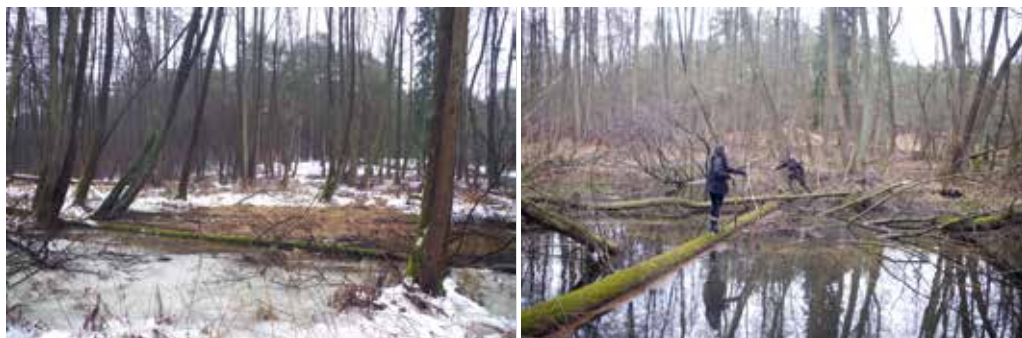
**Figure 72.** To increase the water level in the Pfauenfließ River, structures like logs, branches and soil material were placed in an irregular manner reducing the cross-section of the watercourse (February 2021). Photo: J. Etzold.

Additionally, around 500 m upstream from the bottom glide tree trunks, other plant material, peat and mineral soil were placed into the river (Figure 72). That reduced the cross-section of the stream and thus higher water levels could be reached. In contrast to the original plan (Figures 61, 63), more mineral soil was inserted into the river. This allowed reducing the disturbance to the peatland and exposure of the peat by shallow peat digging.

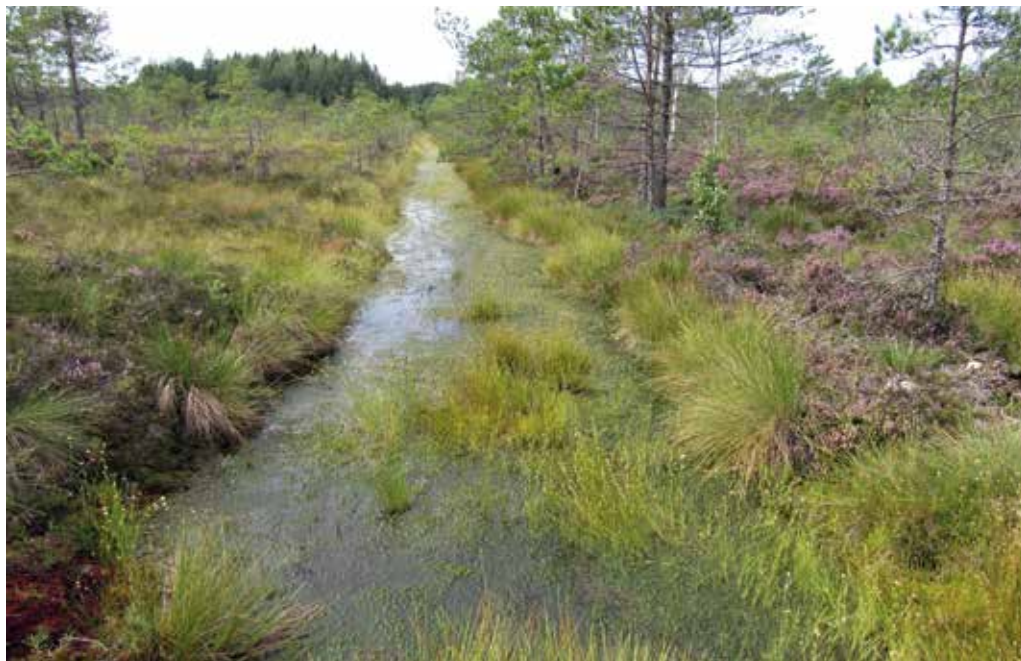
**Figure 75.** A drainage ditch in the Augstroze restoration area, August 2019. Photo: A. Priede.

The northern part of Madiešēni Mire was drained in the period from 1983 to 1998 by a ditch network. In 2019, these ditches (Figure 75) still had a significant negative impact on the raised bog causing degradation over a large area: low water table, compaction of the upper peat layer, decline of *Sphagnum* cover, enhanced growth of dwarf shrubs and trees. Before restoration, several drainage ditches, except for those in the forests on the bog margin, were overgrown. Still, many of them functioned well and had a negative impact on the bog ecosystem.

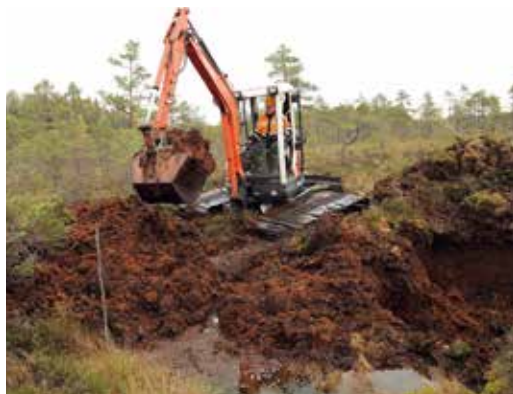
**Figure 78.** *The excavator is building a peat dam.*  
Photo: M. Pakalne.

Prior to the building of dams, dam locations and tracks for movement of machinery were marked, and the trees and shrubs on the tracks cleared. Light mini-excavators (Figure 78) equipped with wide tracks, relatively small in dimensions, were used for building dams. According to the legal restrictions of the particular protected area, the works could be performed at the end of summer, in autumn or in winter, outside the bird nesting season. Experience from the LIFE Peat Restore and earlier peatland restoration projects in Latvia shows that using this type of excavator results in low surface pressure and causes minor damage to the vegetation and the upper peat layer during work and movement of machinery.

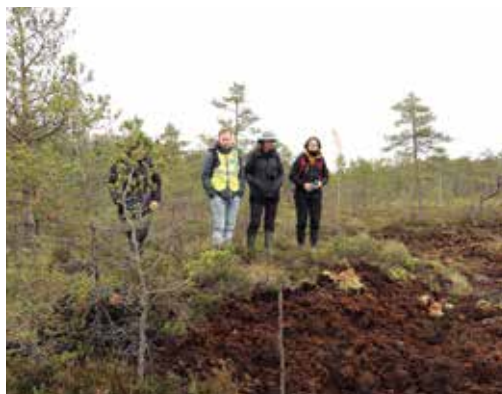
**Figure 79.** *The constructed dam is solid enough to stand on it.*  
Photo: M. Pakalne.

after building the dam, the surface was higher than the surrounding area and wider than the ditch to prevent water infiltration or leaking around the dam. As the last, the topsoil with vegetation was placed on the top of the dam (Figure 79) preventing erosion of the dam and supporting the establishment of bog vegetation on the dam surface.

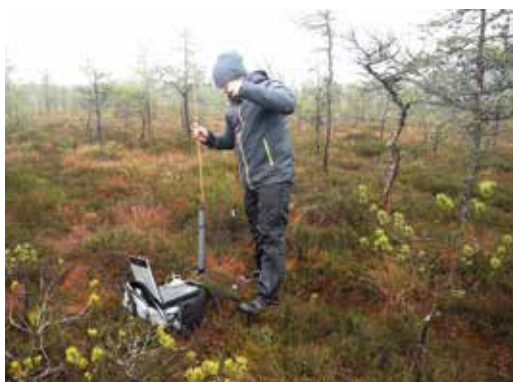
**Figure 80.** *Water level monitoring using loggers.*  
Photo: M. Pakalne.

To monitor the effectiveness of the dams, water monitoring wells were installed in the Madiešēni Mire to record changes in the groundwater level throughout the project (Figure 80). Water level monitoring is carried out in nine wells that are located in three transects with different distances from ditches. The water table was automatically measured by loggers once per hour (except for the periods when the shallow groundwater was frozen) (Figure 81).

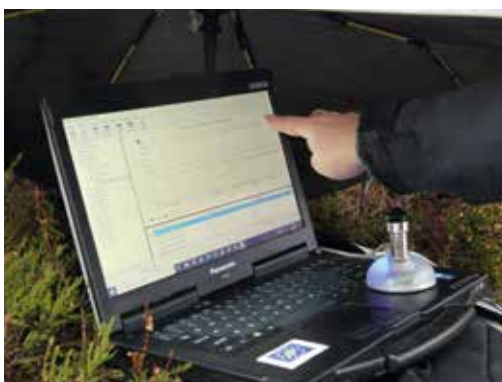
**Figure 81.** *Water level data were downloaded and further processed several times per year.*  
Photo: M. Pakalne.

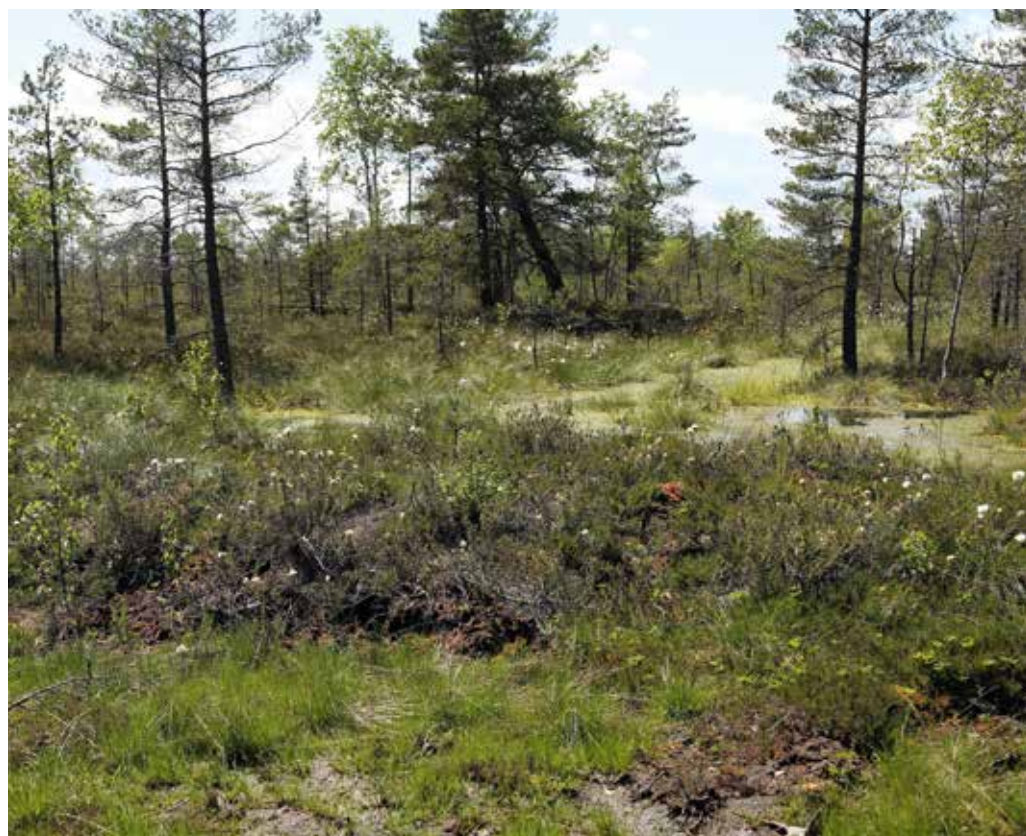
**Figure 86.** One of the peat dams on a drainage ditch, August 2021. Photo: A. Priede.

The monitoring results suggest that restoration has had a positive effect on the hydrological condition of the degraded bog that is the first step toward recovery of the peat-forming vegetation and stabilisation of the entire system (Figures 84–86).

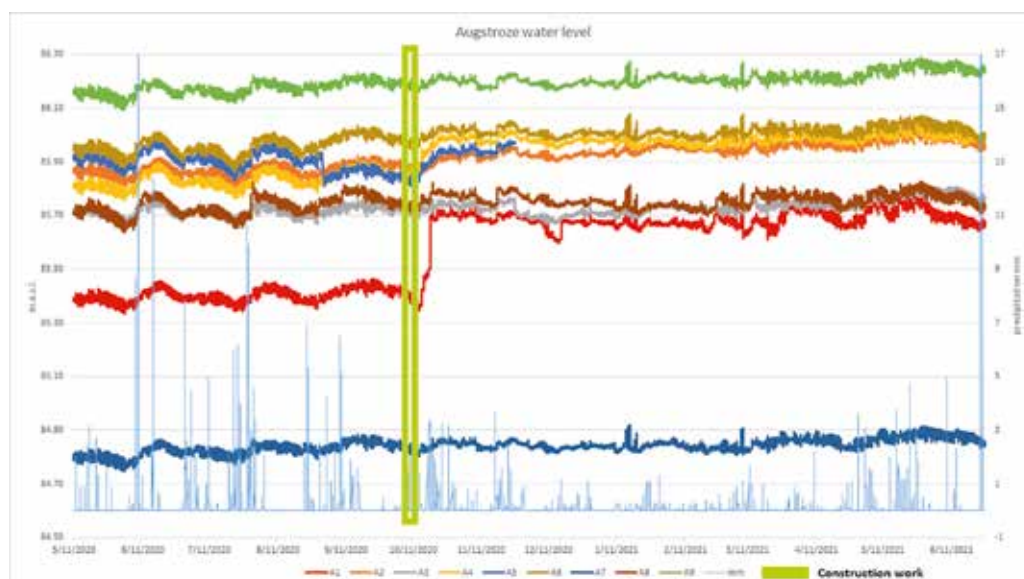
**Figure 87.** Water level fluctuations before and after blocking the ditches in the Augstroze peatland.

After blocking the ditches, the largest increase in water level was observed in the ditches and near the ditches, where the water became stagnant. The observations during the first months after rewetting, i.e. after the construction of the dams, showed that the sharp water level fluctuations near the ditches have stabilised (Figure 87). The formerly dry peat near the ditches is now saturated with water.

In the monitoring wells, the fastest water level increase takes place in those closest to the ditches and dams. For example, in the A1 and A5 monitoring wells blocking of ditches caused an almost immediate increase in water level. In the well closest to the ditch (A1), the lowest water level in the period from 2018 reached 66 cm and the highest groundwater level was 19 cm below the surface in 2021, which was achieved due to the construction of peat dams. The intensity of precipitation also helped to reach the desired groundwater level significantly faster and to keep it stable for a longer period of time. In the first half of 2021, precipitation was significantly higher during the same period in 2020. In 2020, the highest precipitation was observed in May (120.4 mm) and June (62 mm). The average water level in this monitoring well has increased by 26 cm compared to the period before the construction works. This reflects the correct choice of dam design, their operation and efficiency.

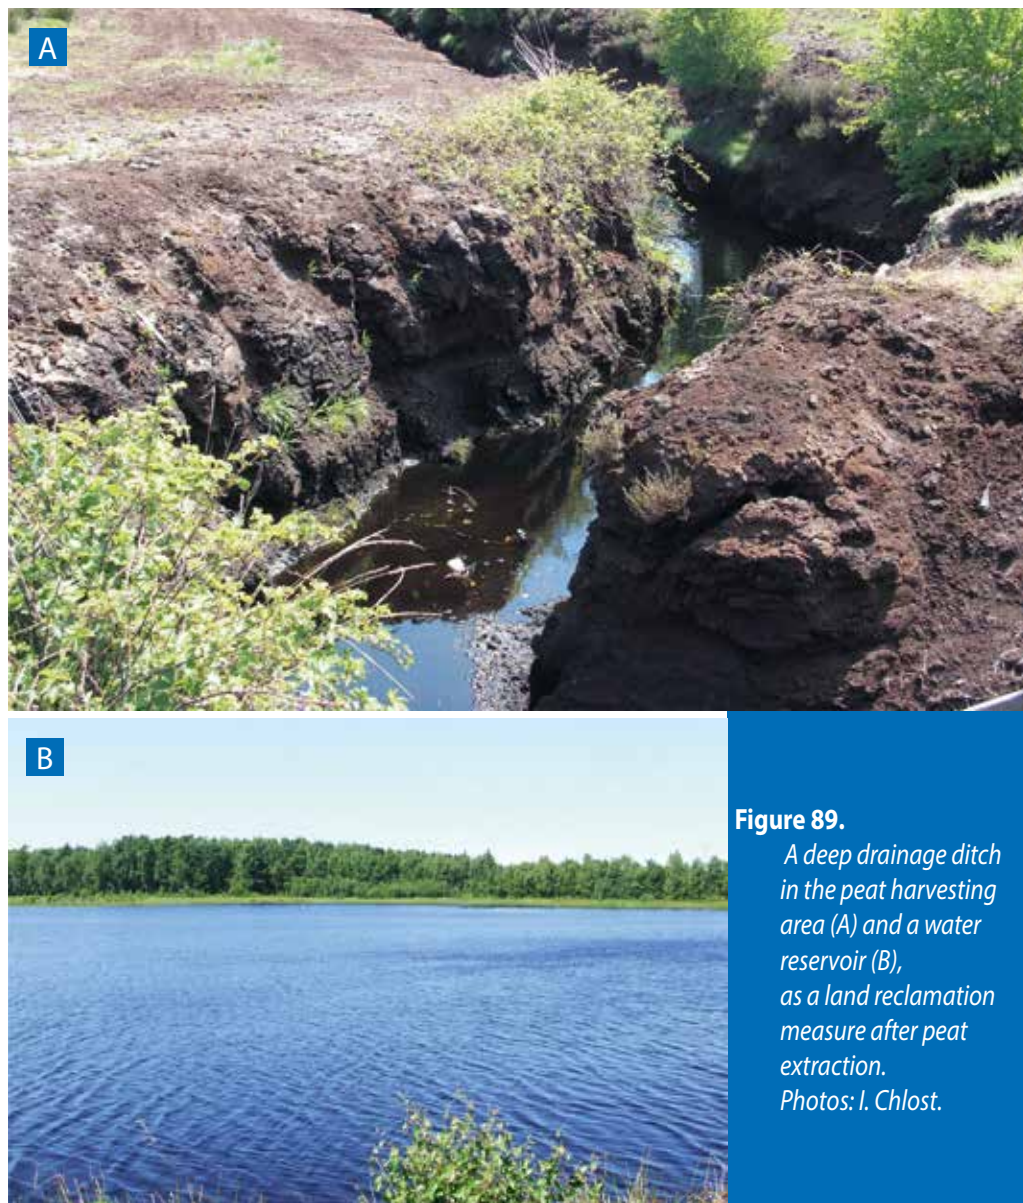
**Figure 89.**

*A deep drainage ditch in the peat harvesting area (A) and a water reservoir (B), as a land reclamation measure after peat extraction.*

There are a few large post-excavation basins in Wielkie Bagno, in the area of peat mine Krakulice, located at the border of SPN, in the southern part of the peatland. They were created as land reclamation measures during the last 20 years and are characterized by poor vegetation succession (Figure 89).

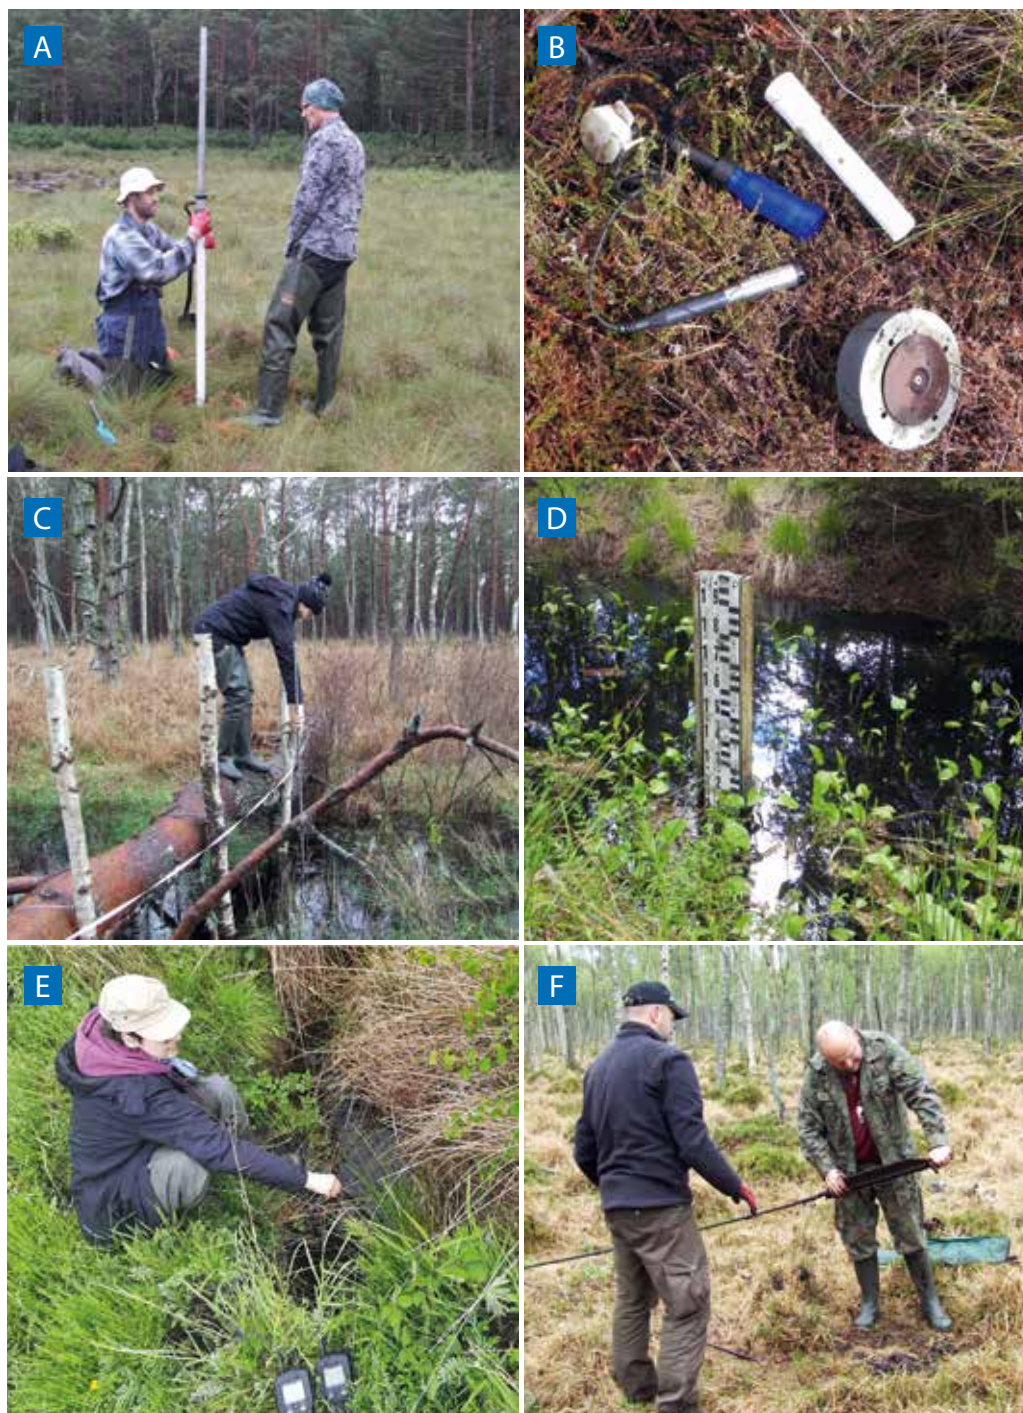
**Figure 92.** Field work: A – installation of piezometers; B – reading data from divers; C – water flow measurement; D – reading the water level from the gauge; E – in situ measurements of surface water parameters; F – collection of peat cores. Photos: I. Chlost (A, B, D, F); M. Pawłowska (E), I. Bubak (C).

Since 2017, the water levels have been recorded twice per day. Water level data were summarised after the end of each hydrological year (the period from 1 November of one year to 31 October of the following year). Once a month, the flow in the ditches from which water escapes beyond the peatlands was measured, and tests of the physical and chemical properties of water were carried out *in situ*: temperature, oxygen, water pH and conductivity (Figure 92). In addition, hydrologists performed seasonal hydrological mapping to determine retention in peat bogs and drainage ditches. Groundwater samples were taken for laboratory tests. In the laboratory, the following parameters and ions were determined:  $N_{tot}$ ,  $P_{tot}$ ,  $HCO_3^-$ ,  $Na^+$ ,  $NH_4^+$ ,  $K^+$ ,  $Mg^{2+}$ ,  $Ca^{2+}$ ,  $Cl^-$ ,  $NO_3^-$ ,  $PO_4^{3-}$ ,  $SO_4^{2-}$ .

Hydrological monitoring also covered a few post-excavating reservoirs, on which limnigraphs were installed to measure the water table fluctuations. Occasionally, the basic physical and chemical properties of water were measured, including oxygen contents, pH and electric conductivity. Due to the lack of data, depth measurements were also made in the reservoirs (Figures 93, 94). The obtained results were the basis for designing the floating islands as a method of initiating re-establishment of mire vegetation in this part of Wielkie Bagno.

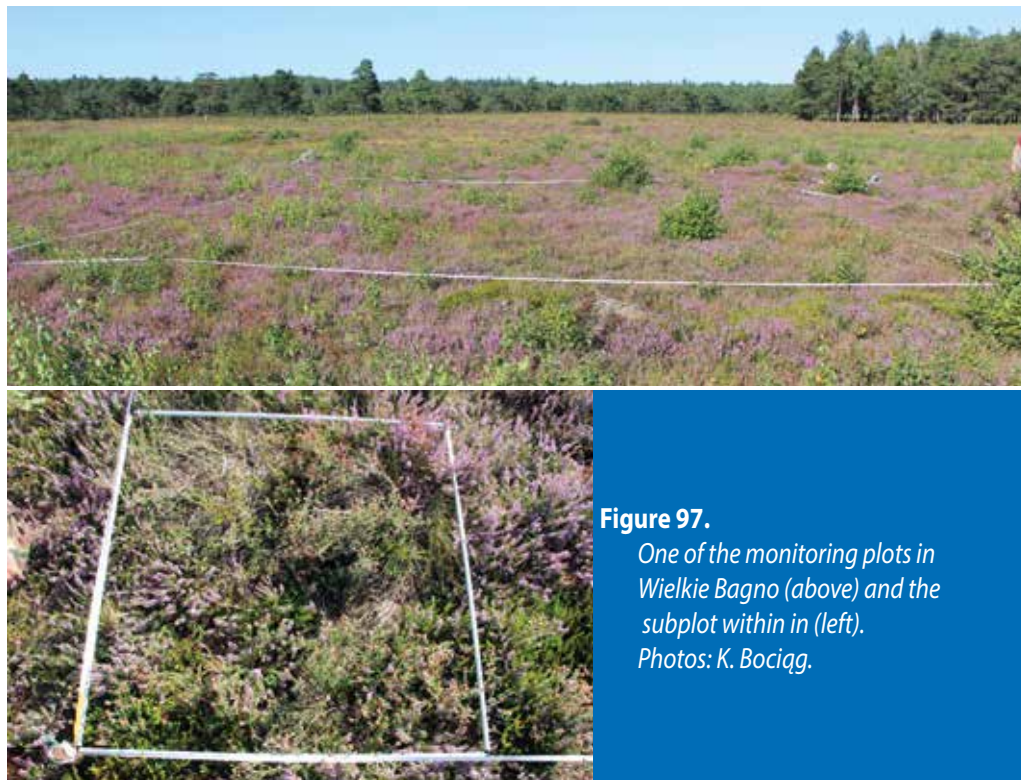
**Figure 97.**

One of the monitoring plots in Wielkie Bagno (above) and the subplot within in (left).

While hydrological monitoring was being carried out and work on planning the details of the blocking of the ditches, the vegetation monitoring in permanent plots was started (Figure 97). The monitoring was carried out using the joint methodology (10 x 10 m plots with 1 x 1 m subplots) agreed among the project partners (see *Chapter 3.2*). In the restoration areas in Poland, in total, 38 monitoring plots were established. The sample plots were located in the patches where rewetting and removal of trees were planned and changes in vegetation expected. The vegetation sample plots were partly located near piezometers recording the water level (hydrological and chemical monitoring).

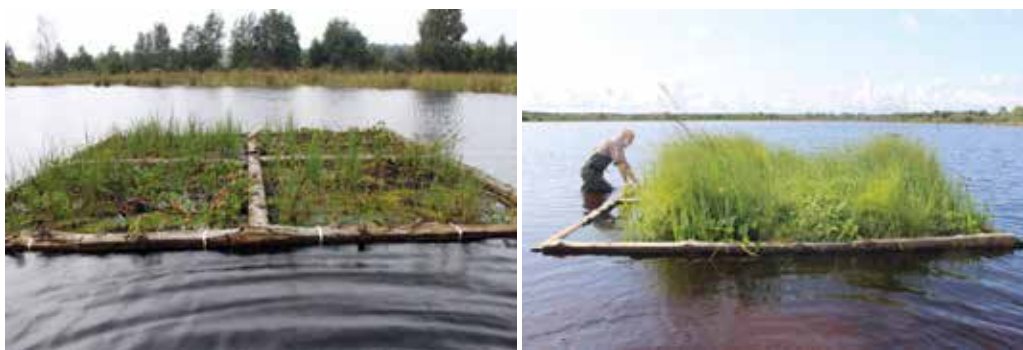
**Figure 98.** *One of the first floating island prototypes after two months (August 2017) and after two years (August 2019) since launching. Photos: K. Bociąg.*

Additionally, from the beginning of the project, tests of floating islands as innovative methods of restoring peat-forming vegetation in areas flooded with water after peat exploitation were performed. Since 2017, in one of the post-excavating water basins in Wielkie Bagno, the prototypes of floating “islands” have been built and tested (Figure 98). Seven different construction types of “islands” were investigated throughout four years, each one for at least two years (Figures 98, 99).

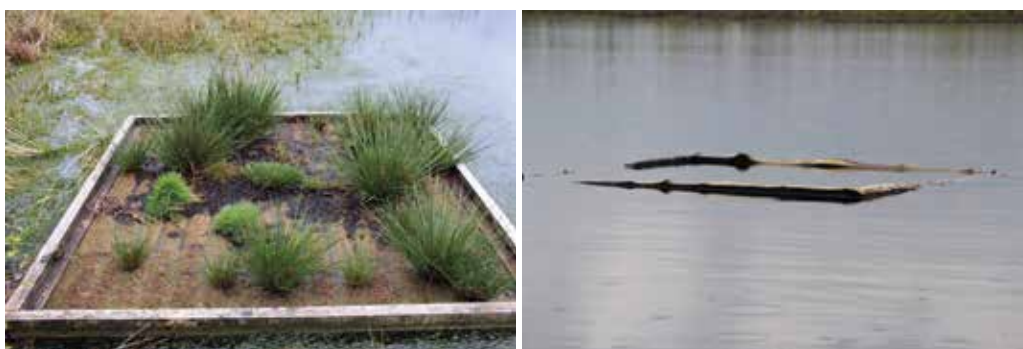
**Figure 99.** *Other prototypes after testing time. On the left – the island which lost anchoring and drifted to the shore (one year since launching in May 2020); on the right – the island which lost buoyancy after two years, May 2020. Photos: K. Bociąg.*

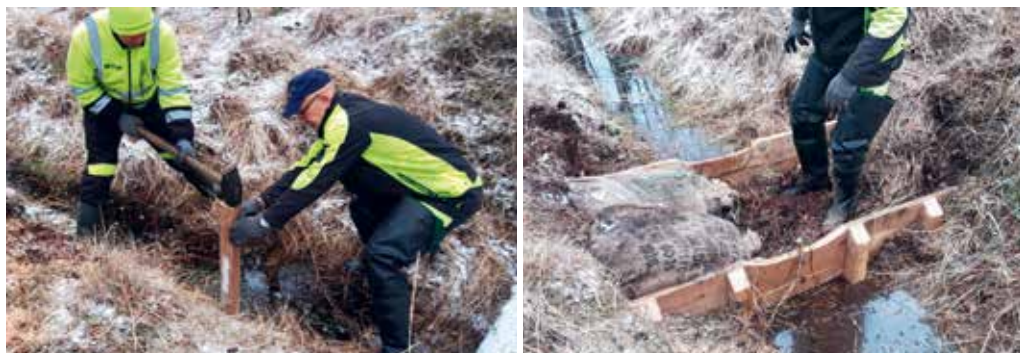
**Figure 100.** Manually built dams in Wielkie Bagno (winter 2021). Photos: W. Spychala.

Following the analysis of local conditions, experience from similar projects and construction of several prototype dams, it was decided to build combined wooden-soil dams (Figure 100).

Their external part consisted of walls made of oak wood boards and reinforced using wooden stakes inserted deep into the ground (Figures 100–103). The space between the walls was filled with burlap sacks filled with a mixture of peat and mineral material. The burlap sacks were used in order to make transportation easier and increase the durability of the structure. Each bag was only half-filled in order to make the construction of a wall easier and to make the bags close-fitting within the wall structure.

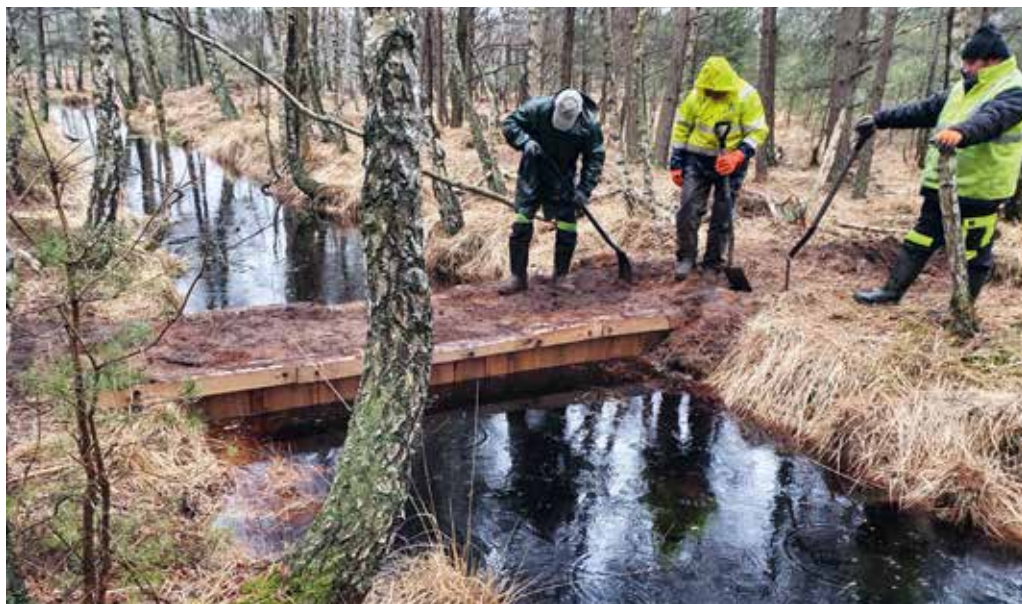
**Figure 102.** Dam building, March 2021. Photo: W. Spychała.

The bags were placed on top of one another resembling the manner in which bricks are used to build a wall – in rows of two to three (Figure 101). Depending on the size and depth of the ditches, dams were constructed using anywhere from 10 to nearly 100 bags. In the case of the largest dams, the two dam walls were linked using beams affixed at right angles. This was done to improve the

In order to assure proper packing and consequently watertightness, sacks were placed in-between wooden walls in the manner of laying bricks in two to three rows. This method helped assure structural durability and the ability to prevent water leaks. Wooden poles were also inserted deep into the floor on the outside of the walls in order to help further reinforce them.

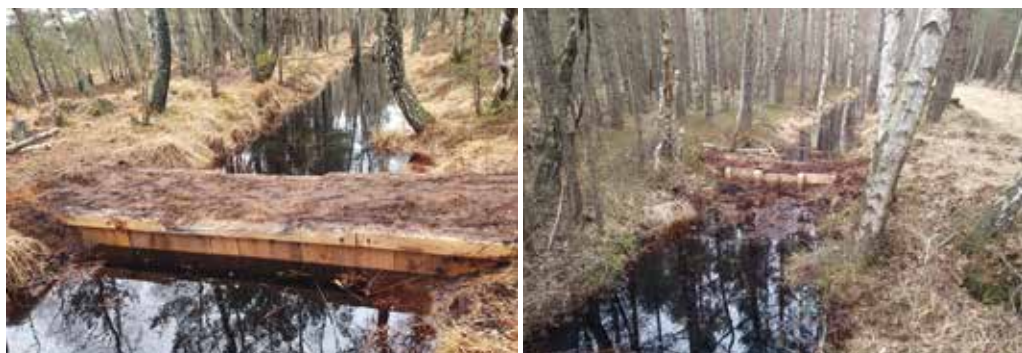
**Figure 103.** Examples of completed dams, March 2021. Photos: W. Spychała.

durability of the wall. The dams were then covered with a thin layer of peat. The construction on the large ditches have an overflow section at the top in order to make sure that at high water levels the water flow will be directed over these sections and not down the sides, which may damage the structure.

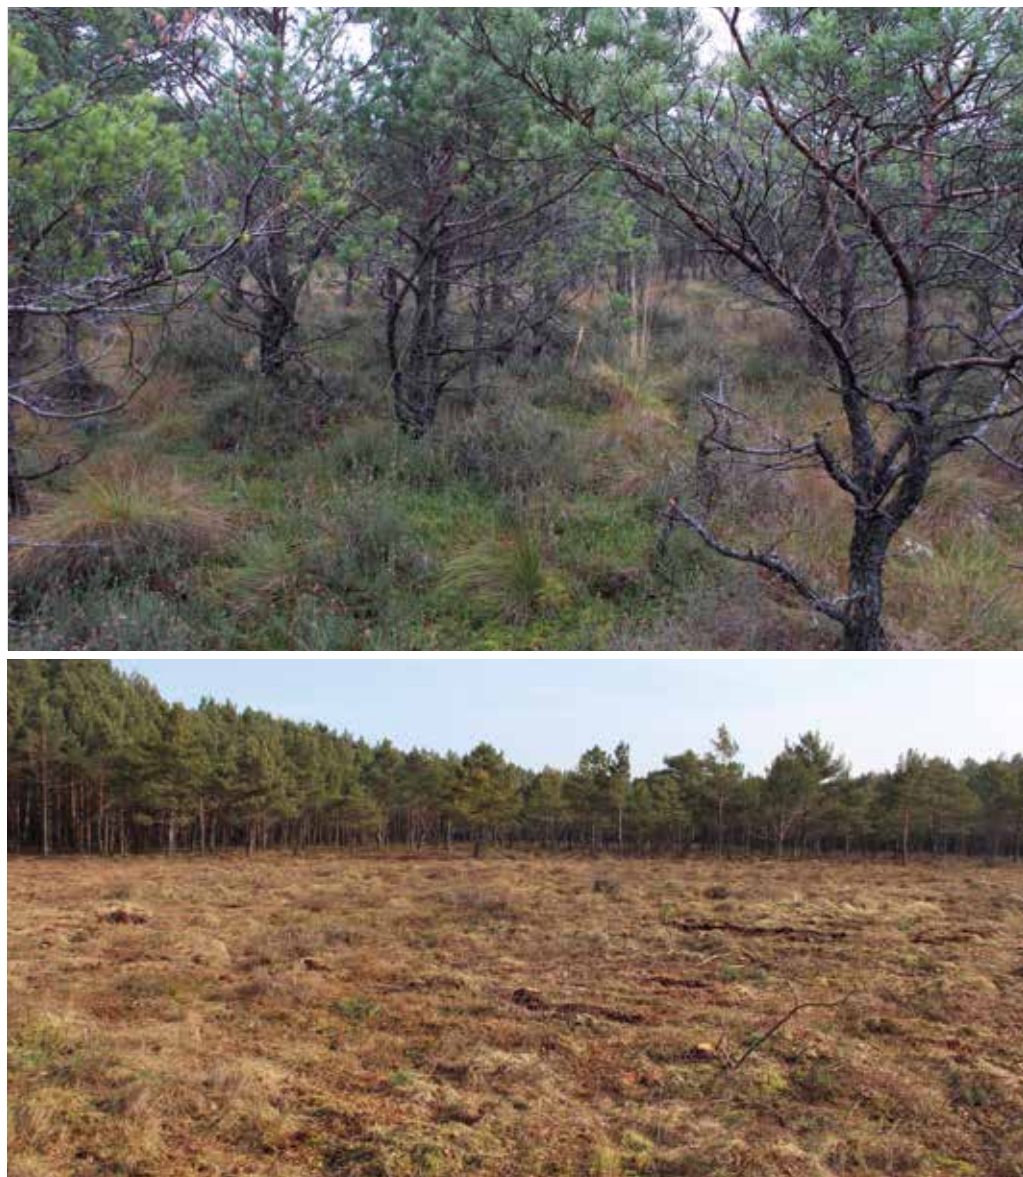
**Figure 104.** A drained bog on Wielkie Bagno before (November 2017) and soon after removal of trees (March 2018). Photos: K. Bociąg.

As mentioned in the previous subchapters, the tree removal was carried out in some selected areas with *Erico-Sphagnetum medii* community overgrown with trees, in several areas with a drained bog woodland with dense tree layers where it hindered the development of peat-forming ground vegetation. Additionally, the measure was implemented in three patches in post-harvested areas where the trees growing on the elevations (former ground level) between longitudinal peat cutting pits (current ground level) created shading on the peat-forming vegetation in those pits. In 2018 and 2019, i.e. before blocking the ditches in 2021, tree cutting in an area of ca. 65 ha were conducted (Figure 104). Trees were cut manually using chainsaws. The biomass was then removed from the restoration target area and stacked outside it in small piles for biodegradation. All that was also done manually or with help of a light, tracked vehicle. It was considered that further transportation of the biomass or leaving it in the ditches would disturb the ground and destroy the ground vegetation. The works were carried out in winter, on the frozen surface of the peat bog.

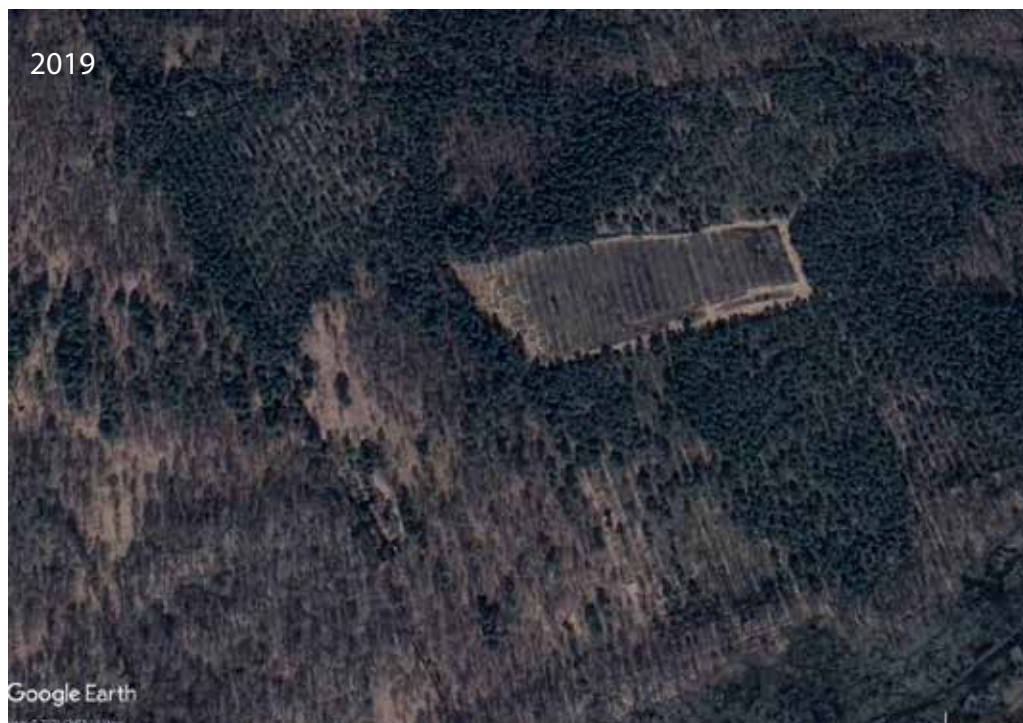
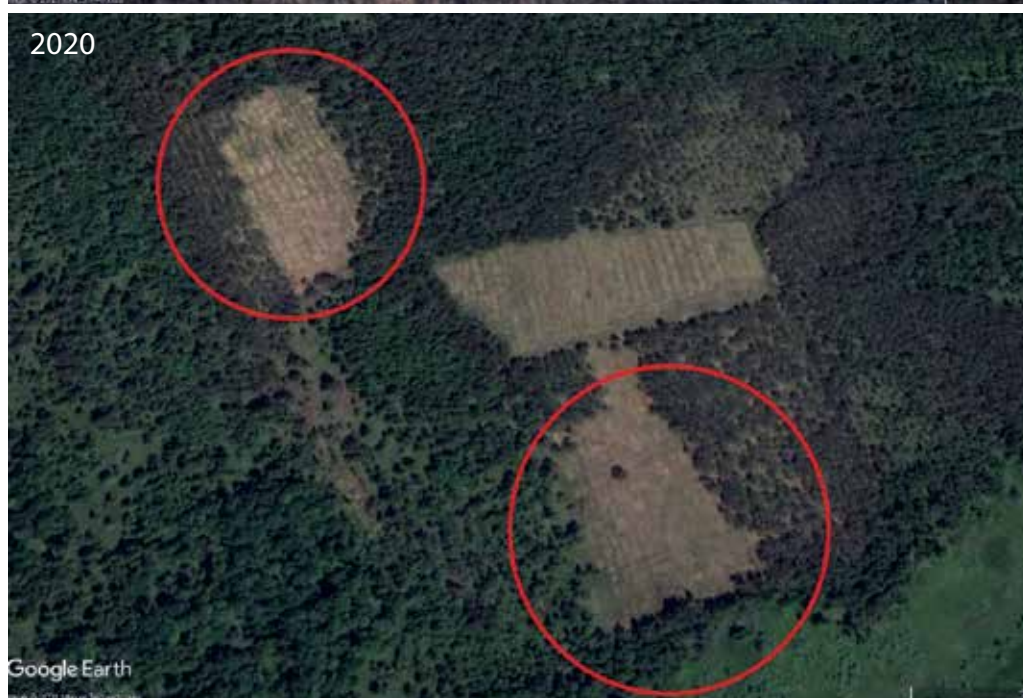
**Figure 105.** Results of tree removal in Kluki, restoration of two post-mining peatland areas with recovered moss dominated vegetation overgrown with trees (in 2019 and 2020). Map background: satellite images provided by Google Earth.

The tree removal from heavily drained bog areas allowed to improve the condition and even enlarge the open bog area, as well as initiated the recovery of peat-forming vegetation in post-harvested areas. Some fragments of orthophotos are presented in Figures 105 and 106 showing the vegetation pattern before and after restoration in Kluki and Wielkie Bagno. One year after the treatment, an increase in herb and dwarf shrub cover was observed in the vegetation monitoring plots. In some plots, the decline of *Sphagnum* cover was observed. However, at the time of this publication the observations covered too short period to interpret the long-term effect of the management.

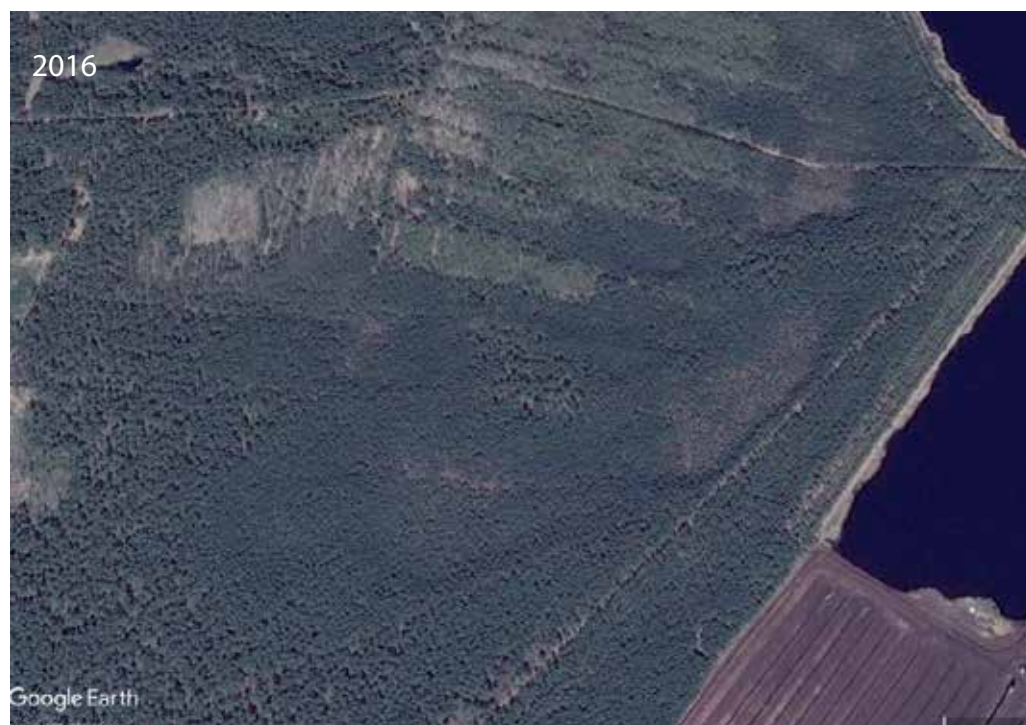
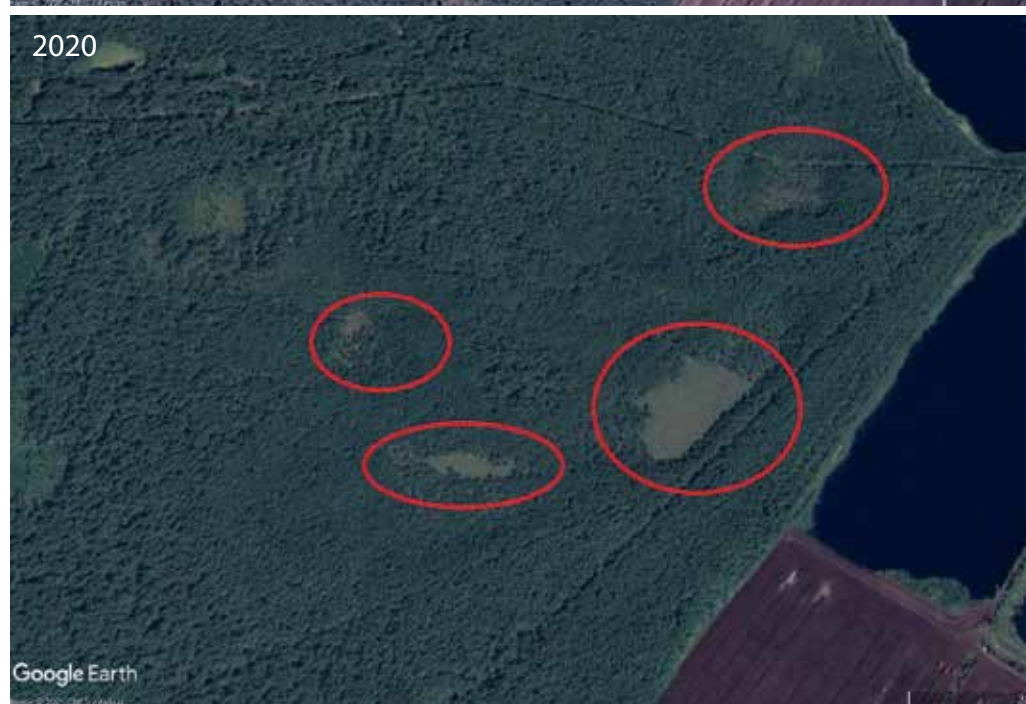
**Figure 106.** Results of tree removal in Wielkie Bagno, restoration of four drained overgrown peatland areas with *Erico-Sphagnetum medii* vegetation (in 2016 and 2020). Map background: satellite images provided by Google Earth.

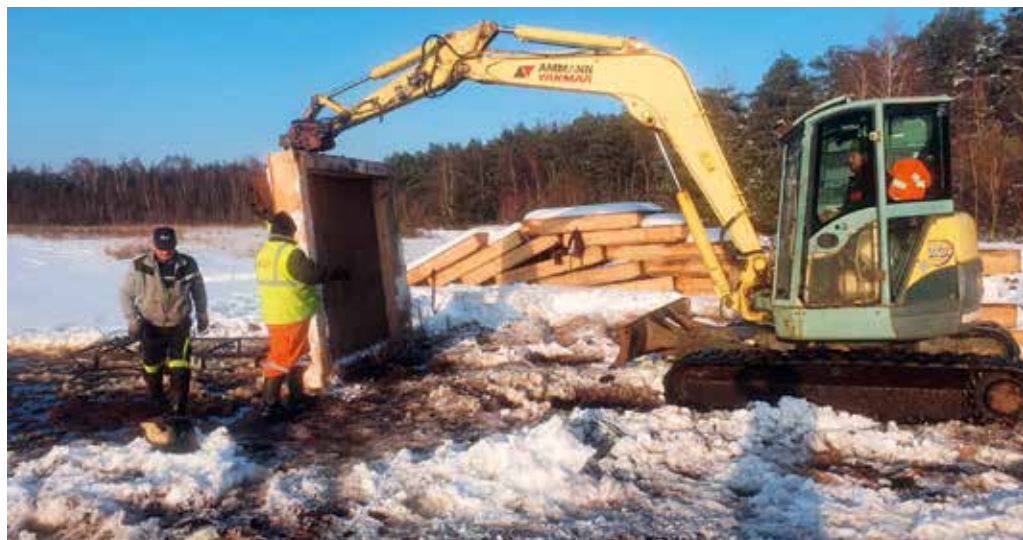
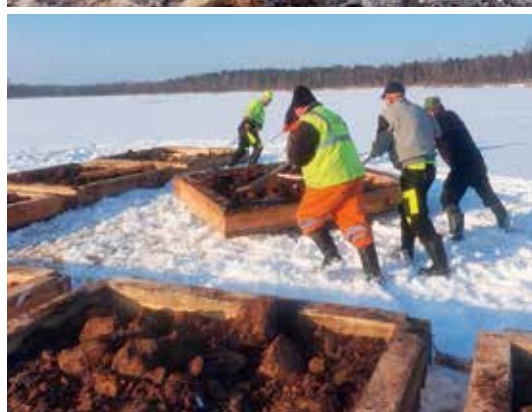
**Figure 108.**  
*Installation of floating islands,  
March 2021. Photos: W. Spychala.*

The islands were installed in early spring 2021. The plan was to launch them from the shore and assemble on the water from a boat. Unexpectedly, at the time of the planned launching, the temperature dropped below 0°C and the basin was covered with thick ice. Eventually, the islands were slipped onto the ice and assembled (Figure 108). It proved to be a much easier and faster solution.

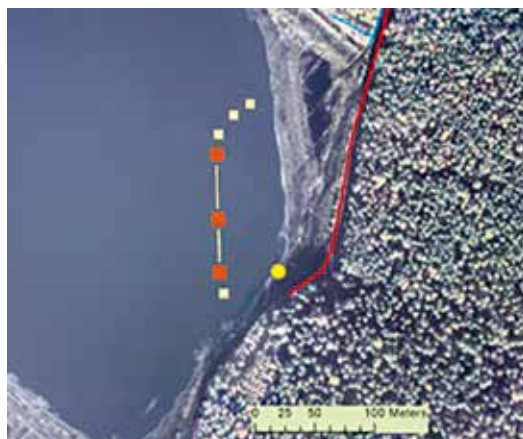
**Figure 109.** *Arrangement of the floating islands on the eastern part of the post-excavating water basin. Red square (on the left picture) – a set of 12 islands (No. 1 in the figure to the right); white square – a set of 8 islands (2), lines – sets of 13 (3) and 10 (4) islands.*

On one of the post-excavating water basins (created as a result of flooding post-excitation site of peat mine in Krakulice) (Wielkie Bagno), after finalising the tests and choosing the most appropriate technical solutions, in total almost 200 floating islands with peat-forming vegetation were installed (Figures 107–111). They are constructed using wood and other natural materials.

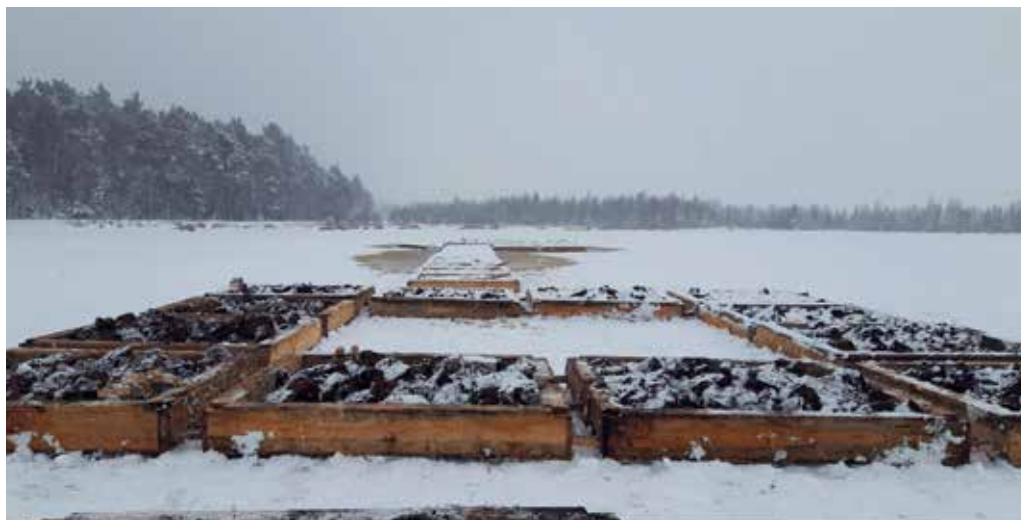
**Figure 110.** Islands waiting on ice for the spring, March 2021. Photo: W. Spychala.

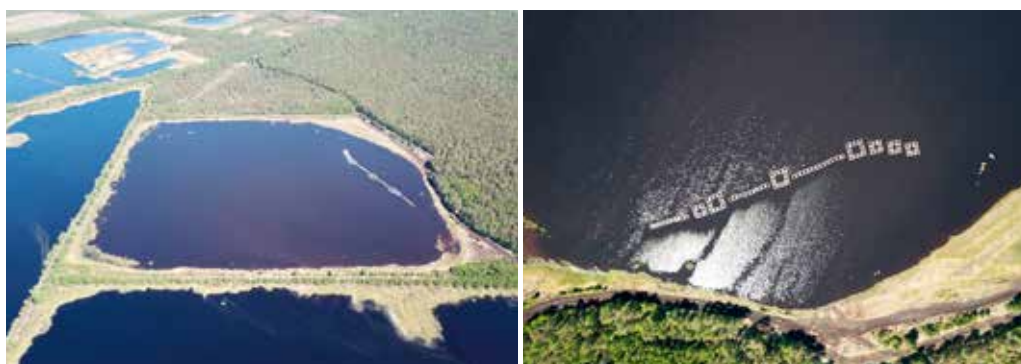
**Figure 111.** Floating islands, views from the drone, May 2021. Photos: A. Olszewska.

The size of a floating island was ca. 2.3 x 2.3 metres. They were made of a wooden frame with double walls, inside which there was an expanded cork. From the bottom, the frame was fastened with a wooden structure, which forms the bottom of the island. Each island had four legs, each 30 cm high, and a chain with a wooden oak pole for anchoring at the bottom. The islands are connected with each other by chains equipped with wooden elements that act as bumpers (Figure 107).
