# Best Practice Book for Peatland Restoration and Climate Change Mitigation – Experiences from LIFE Peat Restore Project

The book was prepared and printed with the financial support of the European Commission's LIFE programme within the project "Reduction of CO<sub>2</sub> emissions by restoring degraded peatlands in Northern European Lowland" (LIFE15 CCM/DE/000138, LIFE Peat Restore).

The LIFE Peat Restore project "Reduction of CO<sub>2</sub> Emissions by Restoring Degraded Peatlands in Northern European Lowland" (LIFE15 CCM/DE/000138, 2016–2021) was financed by the European Commission, LIFE subprogramme "Climate change mitigation and adaptation". The project contributed to the mitigation of climate change in different climatic regions (from 52° NL to 59° NL) in the lowlands around the Baltic Sea in five European countries: Germany, Poland, Lithuania, Latvia, and Estonia. The project highlighted the need to pay attention to degraded peatlands and demonstrated restoration as a tool to reduce CO<sub>2</sub> emissions and mitigate climate change, covering 5300 hectares.

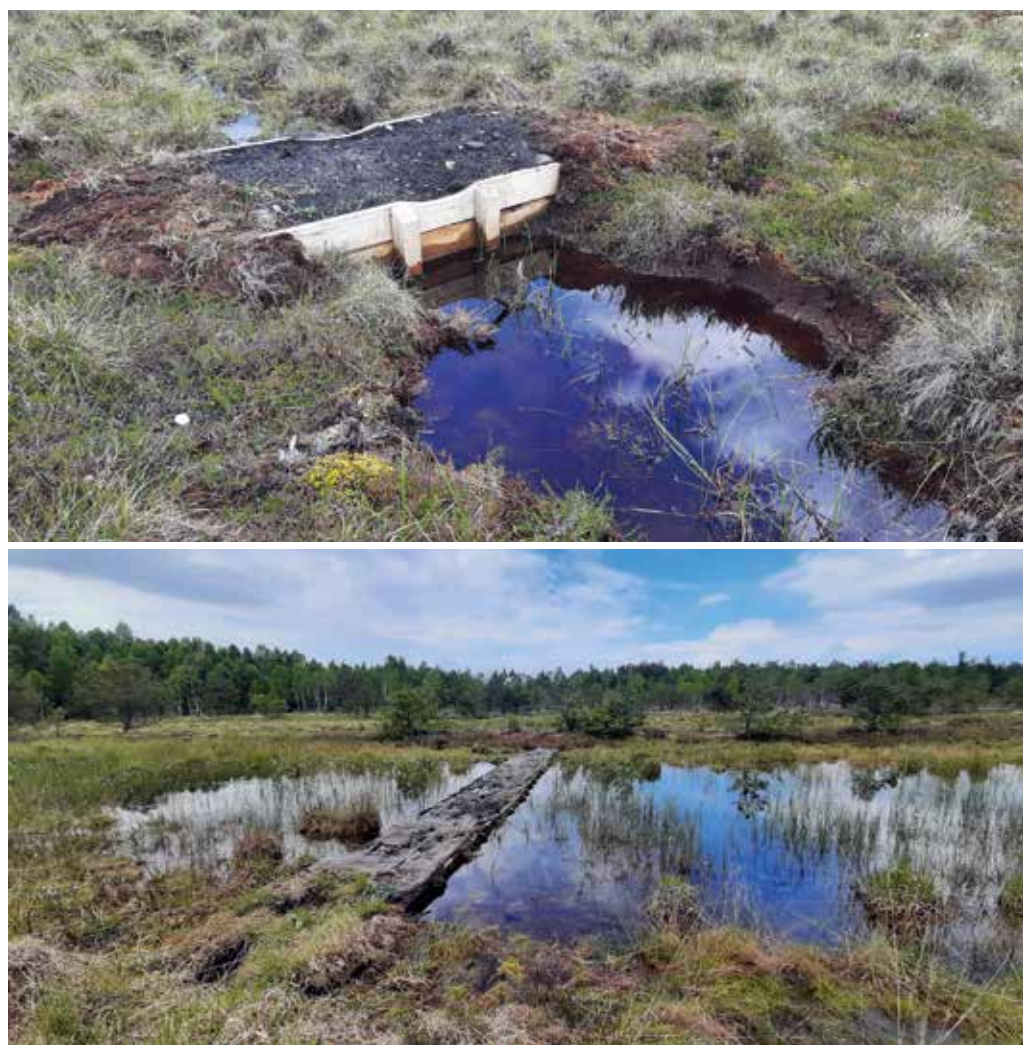
**Figure 114.** Dams in Wielkie Bagno shortly after dam construction, May 2021. Photos: M. Pawłowska.

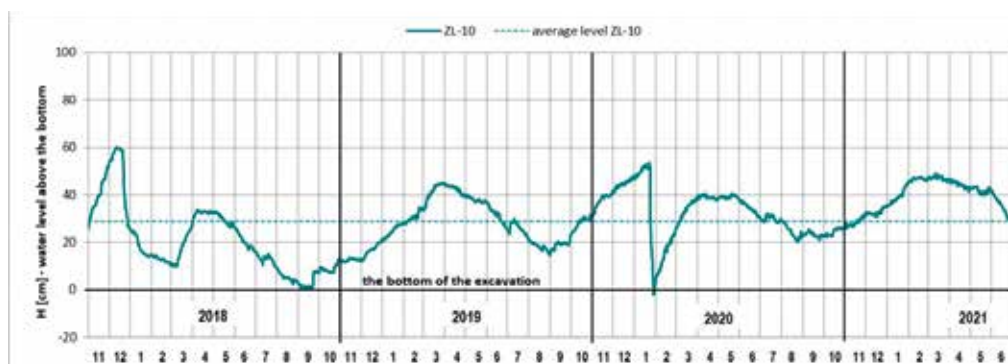
**Figure 116.** Water level fluctuation of the post-excavation basin with floating islands in Wielkie Bagno from the end of 2017 to June 2021.

The results of hydrological observations in the post-excavating basin with floating islands (Wielkie Bagno) are presented in Figure 116. The reservoir is not deep, occupies an area of about 18 ha, and collects from 25 000 to 130 000 m<sup>3</sup> of water depending on the water level. During winters,

an ice cover forms on the surface of the reservoir, which reduces the supply and decreases the water level. This is clearly visible at the turn of January and February 2020, when the ice (without snow cover) formed and caused the drop of water level in the reservoir rapidly. The amplitudes of water level fluctuations in the reservoir reach a maximum of ca. 60 cm during the year and more or less correspond to changes in water retention in most of the bog. Such a range of water level fluctuations should therefore be taken into account in the design and construction of floating islands.

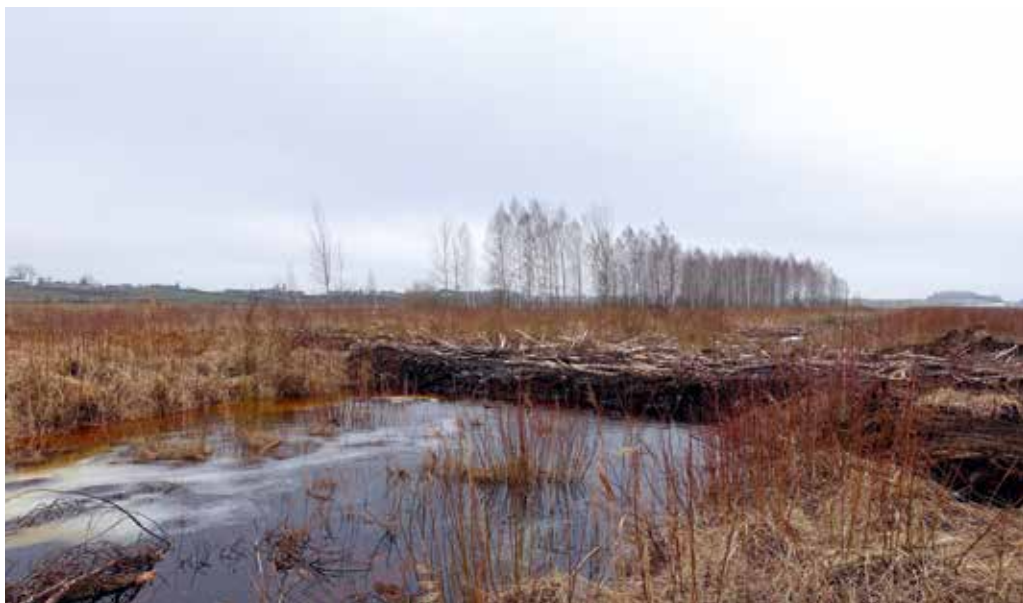
**Figure 118.** *The blocked collective ditch in Amalva, March 2021. Photo: J. Sendžikaitė.*

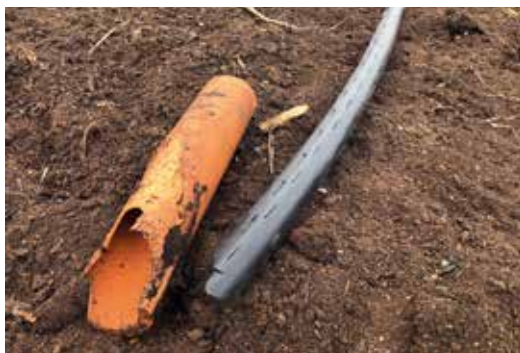
**Figure 119.** *Ceramic and plastic pipes installed to establish a subsurface drainage system were found in Amalva. It is a legacy of the Soviet reclamation school from the late 1980s. Photo: N. Zableckis.*

Restoration measures were implemented in 215 ha of degraded peatland in the southern (the most damaged) part of the Amalva mire complex. In the middle of the 20<sup>th</sup> century, the area was drained by a dense network of open (wide collective ditches and narrow drains) and closed (ceramic and plastic subsurface pipes) drainage (Figures 118, 119). The natural vegetation cover was completely destroyed. However, the planned economic activities were not efficient, thus the site was abandoned for the last four decades. Currently, only one protected habitat of European importance, Degraded raised bogs still capable of natural regeneration (7120), occurs in 30 ha of area (Figure 120). The rest of the peatland is severely damaged and does not meet the requirements for the habitats of European importance.

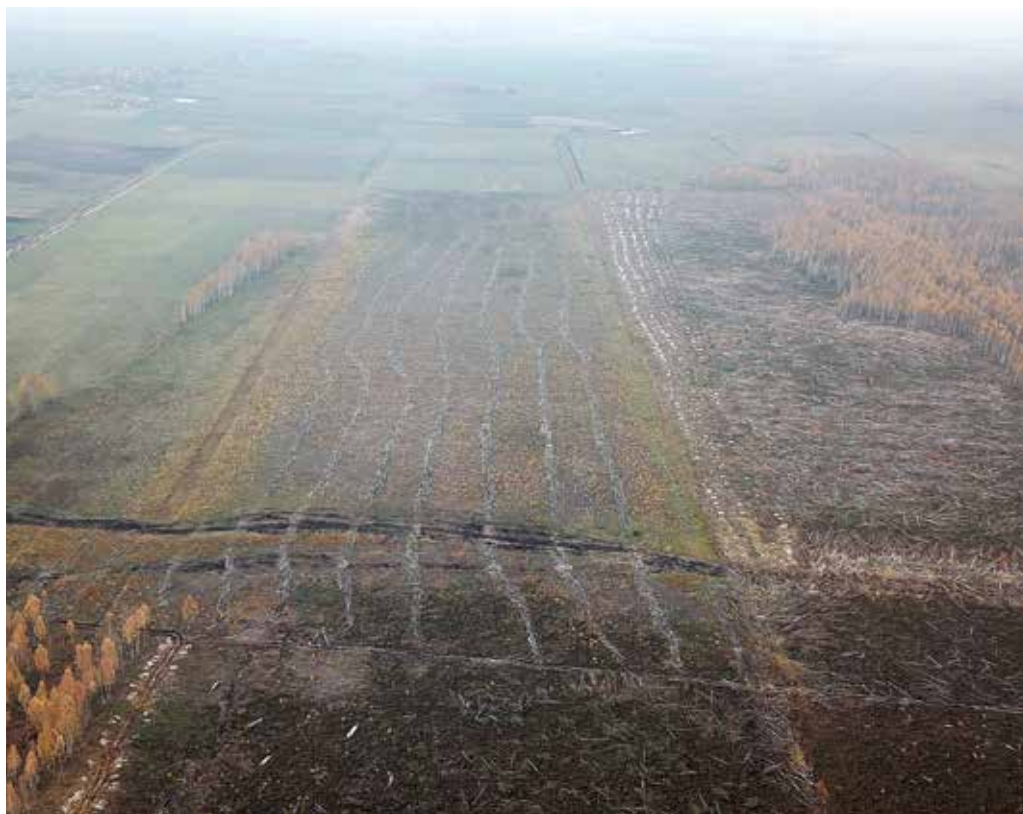
**Figure 124.** *Tree clearing in the Amalva area, November 2020. Photo: Ž. Sinkevičius.*

To improve the hydroecological conditions of the degraded peatland, in addition to rewetting, trees and shrubs were removed in the whole Amalva project area (215 ha) in 2019–2020 (Figure 124). Removal of trees and shrubs was the first step followed by rewetting. Special purpose clearing, e.g. removal of all trees and shrubs was considered the most appropriate method.

Special purpose clearing in 200 ha performed by the State Forestry Enterprise, the manager of state-owned forest lands, while 15 ha of non-forest land overgrown by shrubs and young trees (classified as the habitat type Degraded raised bogs still capable of natural regeneration (7120)) in the central part of the area was managed by a subcontractor.

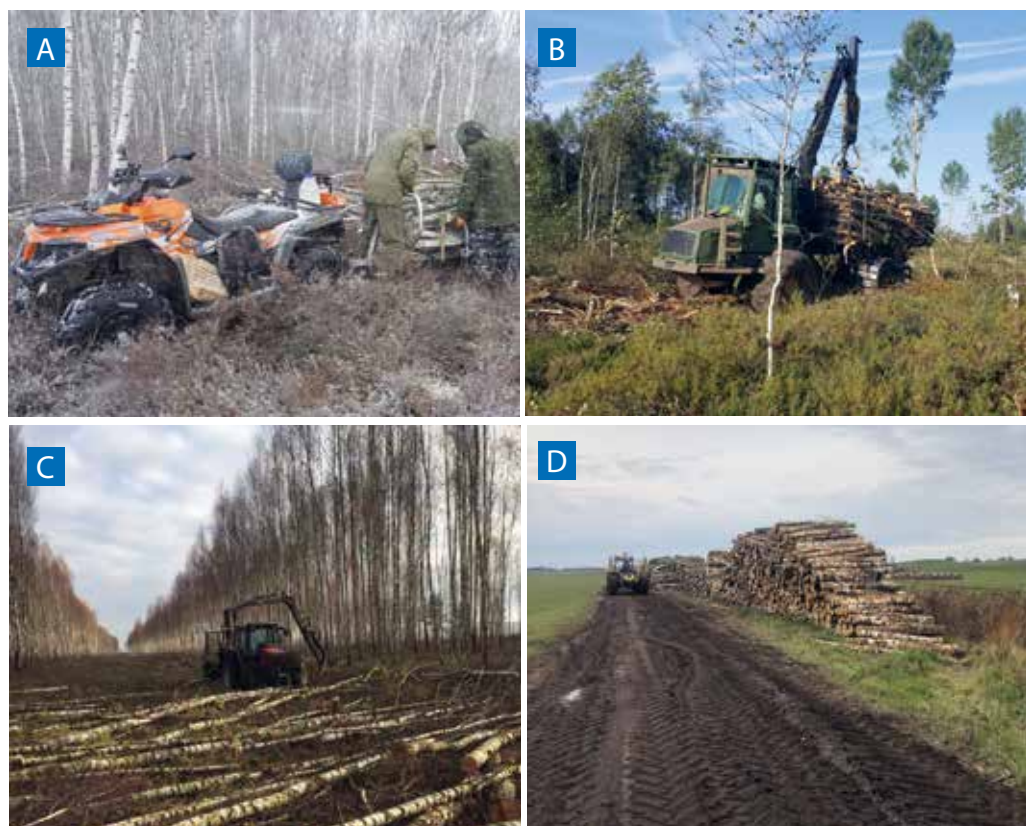
**Figure 125.** Removal of woody vegetation from the Amalva area: A – by light minitractor with a small trailer, March 2019; B and C – by heavy machinery (forwarders); D – timber yard on a roadside near the project area. Photos: Ž. Sinkevičius (A–C), N. Zableckis (D).

The special purpose clearings aimed at supporting biodiversity and climate mitigation in the Amalva peatland was among the largest forest cuttings in Lithuania so far done for peatland restoration. Approximately 20 000 m<sup>3</sup> of timber was cut, the majority of it was removed and sold by the State Forestry Enterprise (common practice), while the LIFE project purchased several hundred cubic metres of logging waste (branches, trunks) to fill it in the ditches to level the surface. The clearing and wood removal was performed by machinery, except for the central part of the peatland where forest clearing was done manually due to the vulnerability of the peat soil and ground vegetation. The rest of the area was dry (deeply drained), therefore machinery could access the area (Figure 125).

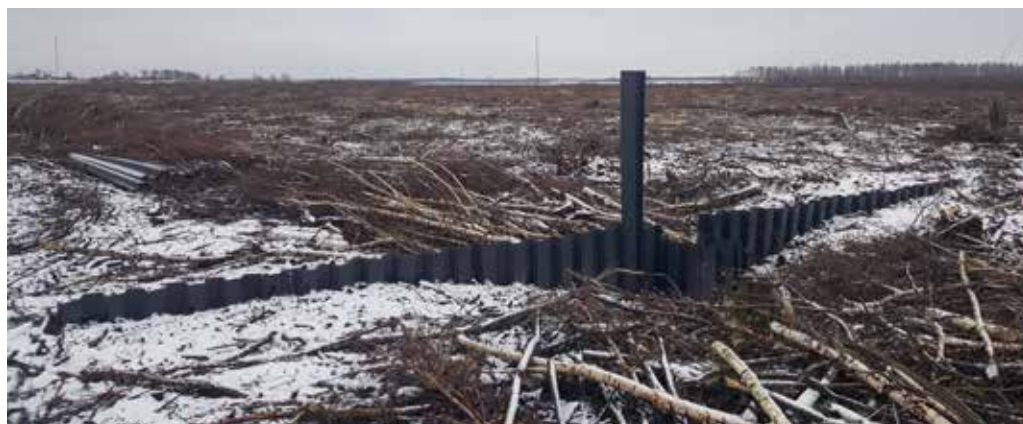
**Figure 126.** *Installation of the plastic pile sheets dam. February 2021. Photo: Ž. Sinkevičius.*

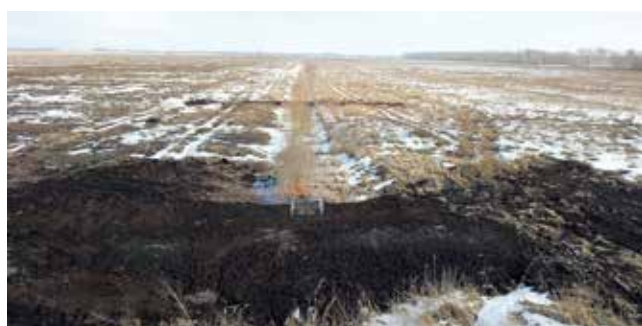
**Figure 127.**  
*Blocked collective ditch in the  
Amalva peatland,  
February 2021.  
Photo: Z. Sinkevičius.*

As the next step after tree removal, rewetting measures were implemented. Actions to restore the hydrological regime were performed by a local contracted company JSC “Alytaus melioracija”, which is experienced in such works in Lithuania. Actions were performed in winter of 2020/2021. Wide-track excavators were used for building 28 composite dams on wide collective ditches. These dams were 4–10 m wide and made of plastic pile sheets and peat (Figure 126). Plastic pile sheets were mainly constructed manually using a hammer and later to make this construction solid and waterproof, excavators filled the ditch with compressed peat from both sides. In addition, four special dams supported by water outflow construction were built on the edges of collective ditches (Figure 127–129).

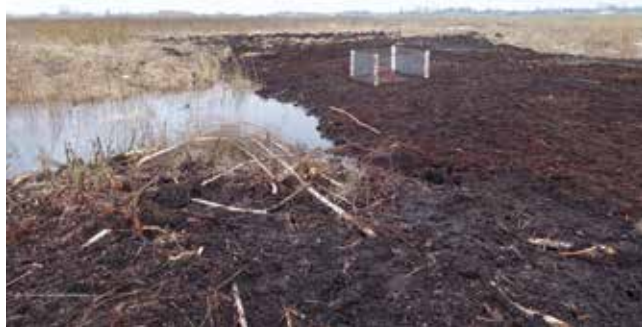
**Figure 128.**  
*Dam with water outflow  
construction in Amalva  
peatland,  
March 2021.  
Photo: J. Sendžikaitė.*

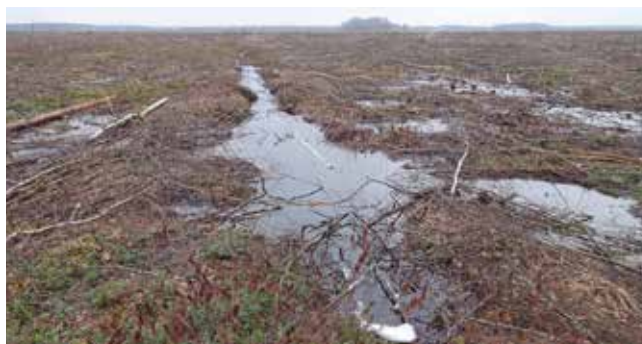
**Figure 130.**  
*Rise of water level in the  
ditches in the Amalva  
peatland was observed  
immediately  
after blocking the ditches,  
March 2021.  
Photo: J. Sendžikaitė.*

The results of hydrological monitoring show that the restoration has a positive effect on the hydrological conditions, as the water level increased very soon after the dam construction and raised above the peat surface during the following spring (Figures 130-131). However, to assess the restoration effect in the longer term more time is required.

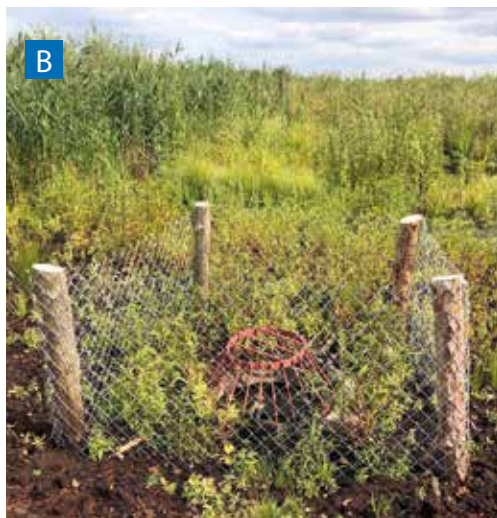
**Figure 129.**

*Dam with the water outflow construction. Cross section of the dam (A) and view of a fenced concrete well for water outflow on the top of the dam (B). The dam is made of plastic pile sheets, peat, concrete well, plastic tube, protective metal fence and grid. Using this kind of construction will prevent plugging the outflow pipe with the litter (leaves and branches) and protect from undesirable activity of beavers. Scheme: JTC "Inžinerinis projektavimas". Photo: N. Zableckis.*

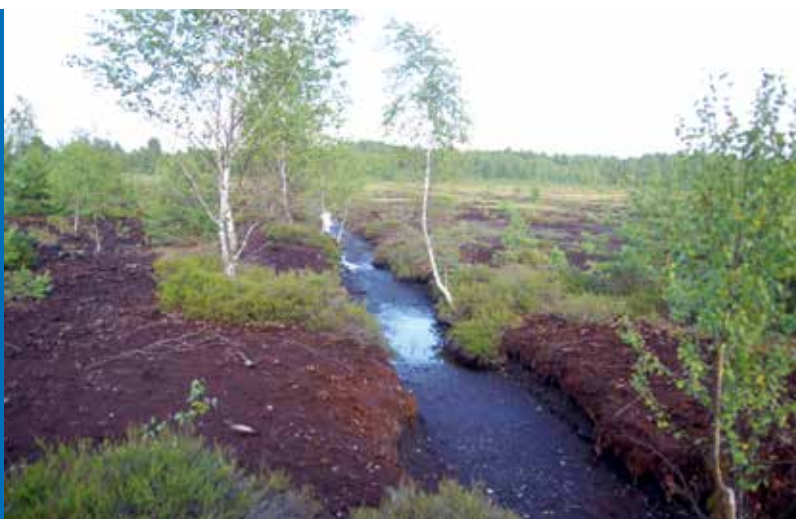
**Figure 138.**

*Old drainage system before rewetting in 2018. Photo: L. Jarašius.*

Three decades of industrial peat extraction and intensive drainage has severely altered the raised bog (Figures 134A). After cessation of peat extraction, piles of peat and tree stumps remained. Moreover, some of the draining pipes were left under the peat surface and thus continuously drained the area. This caused a significant decrease of water level: up to 1 m below the peat surface during the dry season. Before restoration, the site was dominated by vegetation characteristic to post-harvested peatlands with species-poor, degraded vegetation and a large proportion of bare, unvegetated peat surfaces (Figures 133, 134B–C, 135, 137, 138).

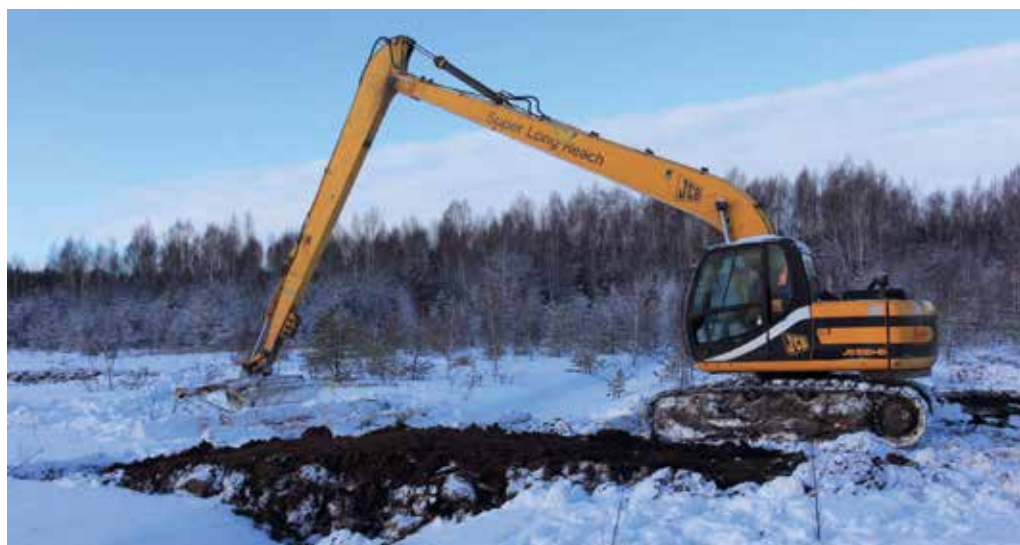
**Figure 145.** Installation of a peat dam in the Pūsčia area. Photo: Ž. Sinkevičius.

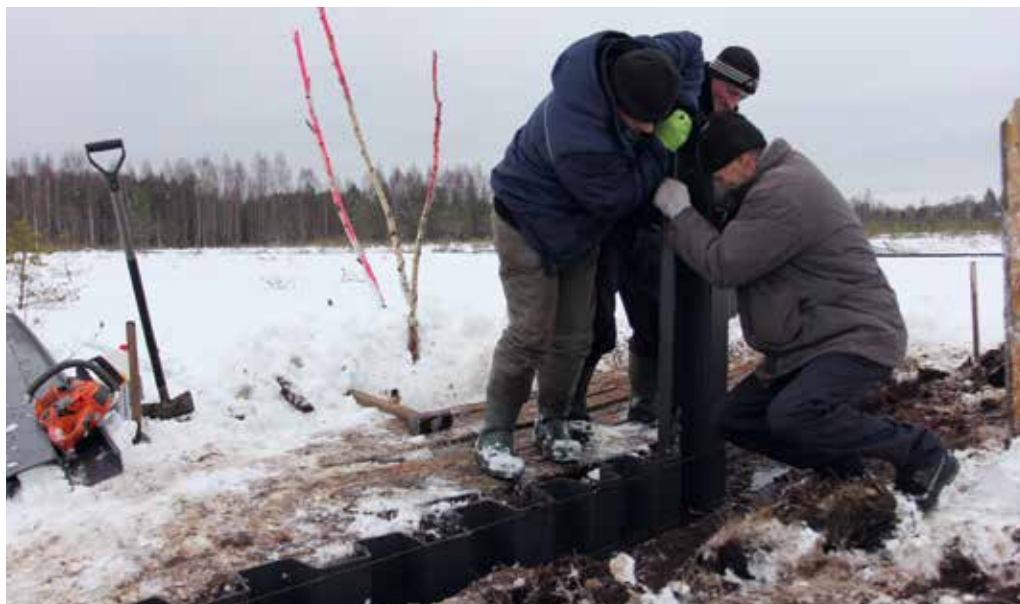
**Figure 145.** Installation of a peat dam in the Pūsčia area. Photo: Ž. Sinkevičius.

In order to restore favourable hydrological conditions, in 2019, 65 peat dams, 35 plastic pile sheet dams and three composite dams (made from plastic pile sheets and peat) were installed and the old subsurface drainage pipes (more than 100) were broken (Figures 145–149). To break the old drainage pipes the same principle as in the Amalva site was followed.

The building of dams was performed by the contracted regional company JSC “Anykščių melioracija”. Ditches (0.5–2.0 m width, 1.0–1.6 m depth) were dammed using the local peat in the areas accessible with heavy machinery. For this purpose, an excavator (12 t weight) with widened tracks (up to 80 cm) was used. Before building dams, the place for damming was prepared by removing stumps, vegetation and the top layer of the highly decomposed peat and set aside. The cleaned place was filled in by peat; if possible, it is advised to use wet peat taken from deeper peat layers, as it has a higher water accumulation capability. Peat must be compressed by the excavator bucket while filling up the ditch, thus the built dam will be less permeable. Later, the small (30–40 cm) embankment on the top of the dam was built in order to avoid the outflow of surface water (Zableckis et al. 2017). The schemes of peat dam installation are provided in Figure 150. Plastic pile sheets were installed manually and later reinforced by metal plates (Figures 146, 147).

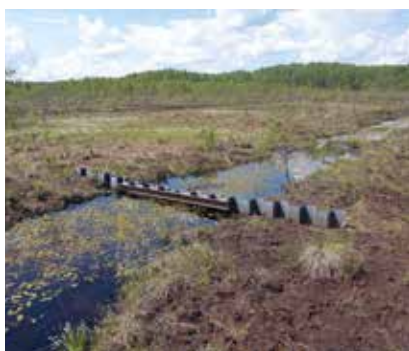
**Figure 147.** Plastic pile sheet dam.  
Photo: J. Sendžikaitė.

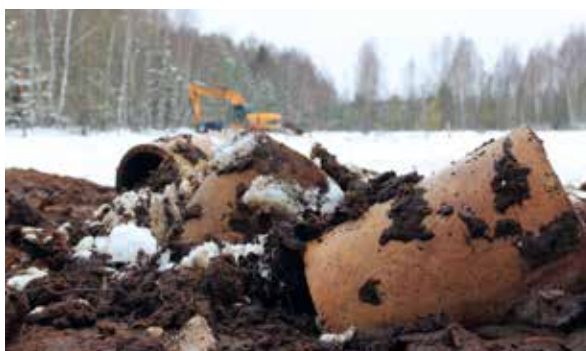
**Figure 148.** Old asbestos pipes were broken in order to restore water level in the Pūsčia peatland.  
Photo: J. Sendžikaitė.

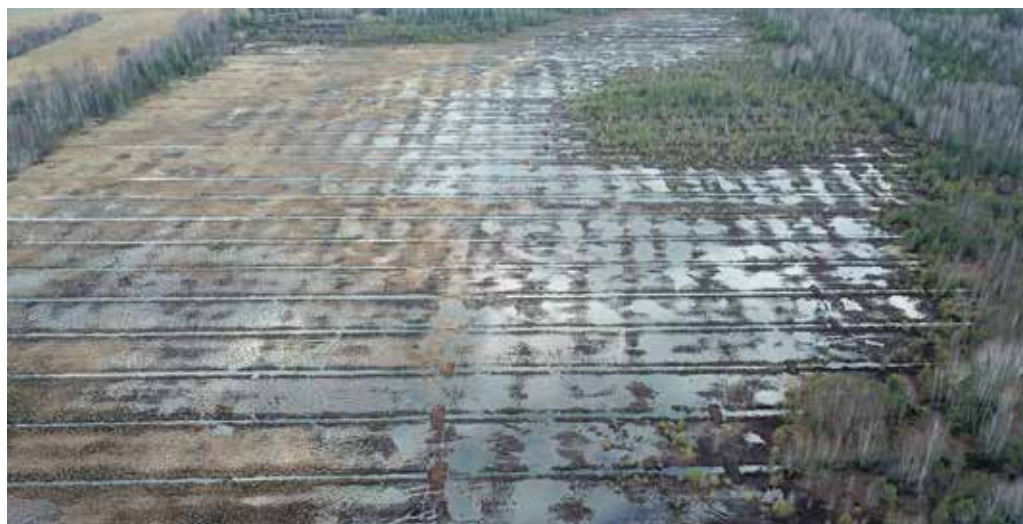
**Figure 149.** The rise of water level was particularly obvious during the spring flood season, March 2019. Photo: Ž. Sinkevičius.

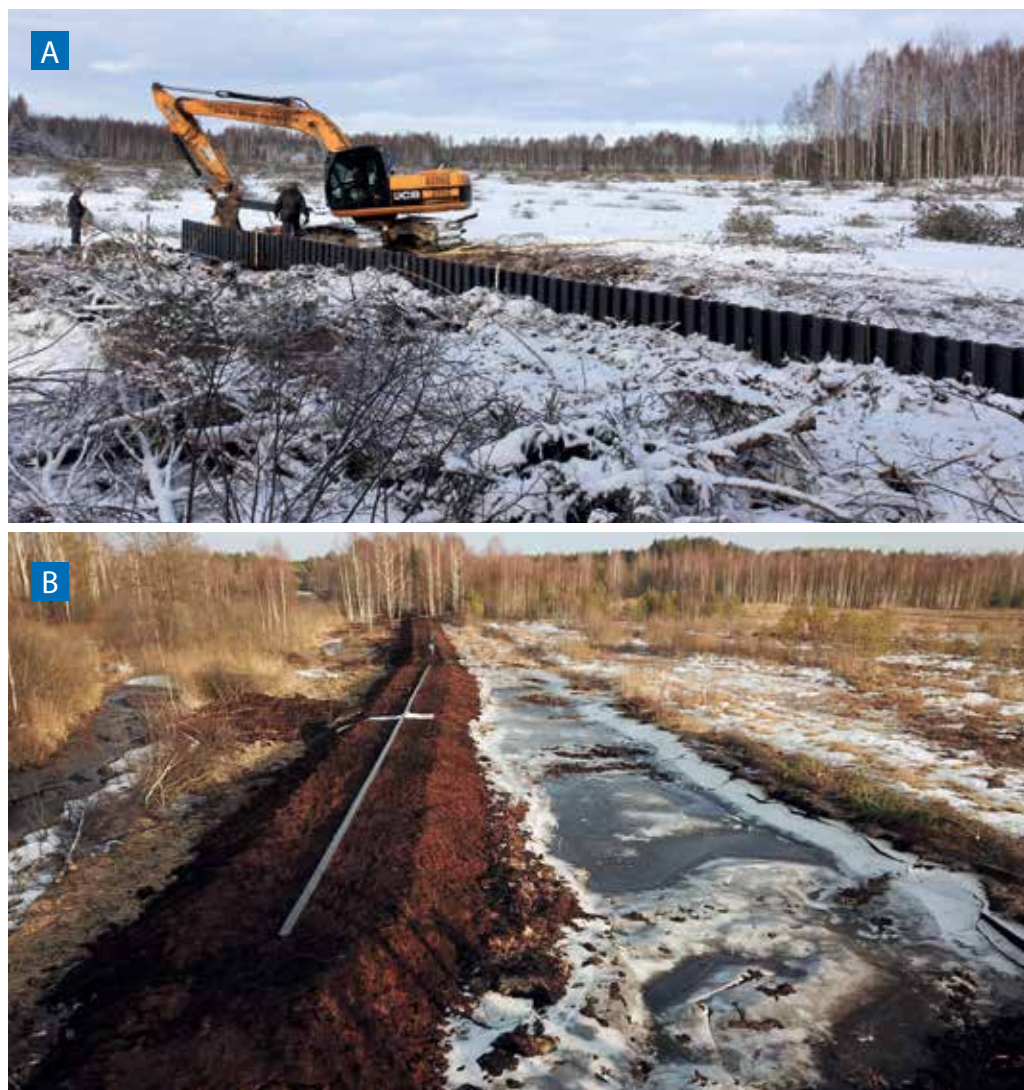
**Figure 151.** *Protective peat embankments reinforced with plastic pile sheets. Construction process (A) and the installed embankment (B), February 2019. Photos: Ž. Sinkevičius.*

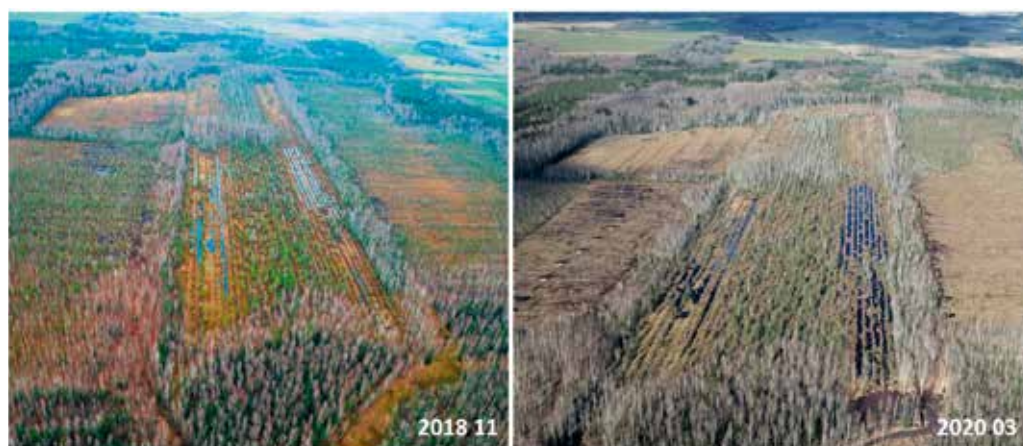
**Figure 159.** Sachara peatland before (left) and after (right) restoration. Photos: Ž. Sinkevičius.

The forest covering 30 ha (mainly birches and pines with an admixture of spruce *Picea abies*, established after drainage) was cleared because it caused increased evapotranspiration and thus unfavourably affected the hydrological condition of the peatland (Figures 159, 160). In addition, the special purpose clearings were applied in 4 ha, i.e. in the areas where later the ditches were blocked by dams. Additionally, technological clearings for creation of special “corridors without trees” were performed to ensure accessibility for the machinery to reach dam building locations. In this way, almost 34 ha of forest were cleared. Part of the work (3 ha) was performed by the State Forestry Enterprise. In total 1648 m<sup>3</sup> of timber was cut, out of which 721 m<sup>3</sup> (457 m<sup>3</sup> by the State Forestry Enterprise, and 264 m<sup>3</sup> by the LIFE project subcontractor) were removed from the bog. 264 m<sup>3</sup> of timber were sold as an income for the project. The rest of the timber was laid into the drainage ditches to provide a substrate for the colonisation of *Sphagnum* mosses. The forest clearing was performed mainly manually; harvesters were used only in some drier places.

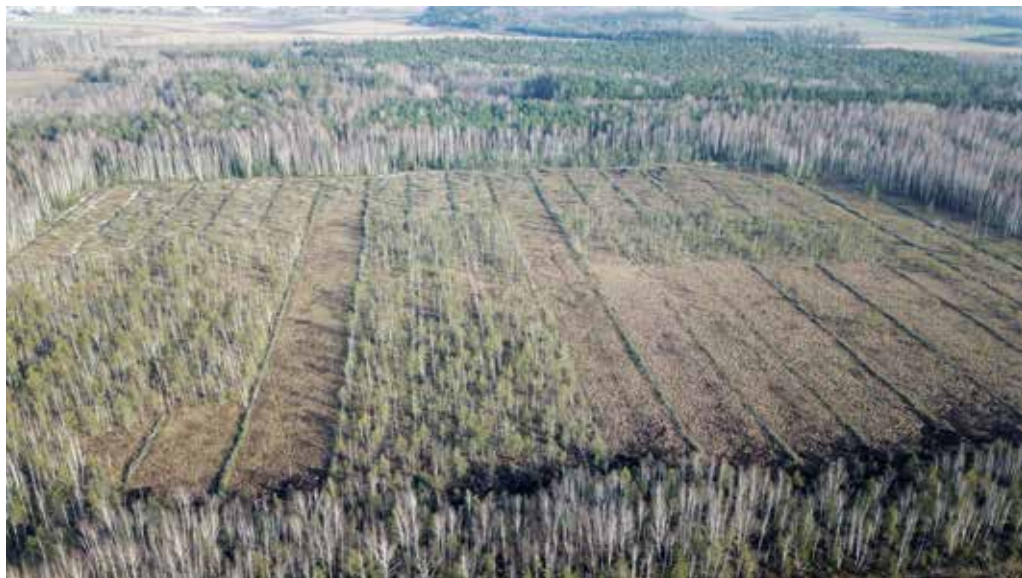
**Figure 160.** *Tree cutting was performed manually in a large part of the Sachara peatland, March 2020. Photo: Ž. Sinkevičius.*

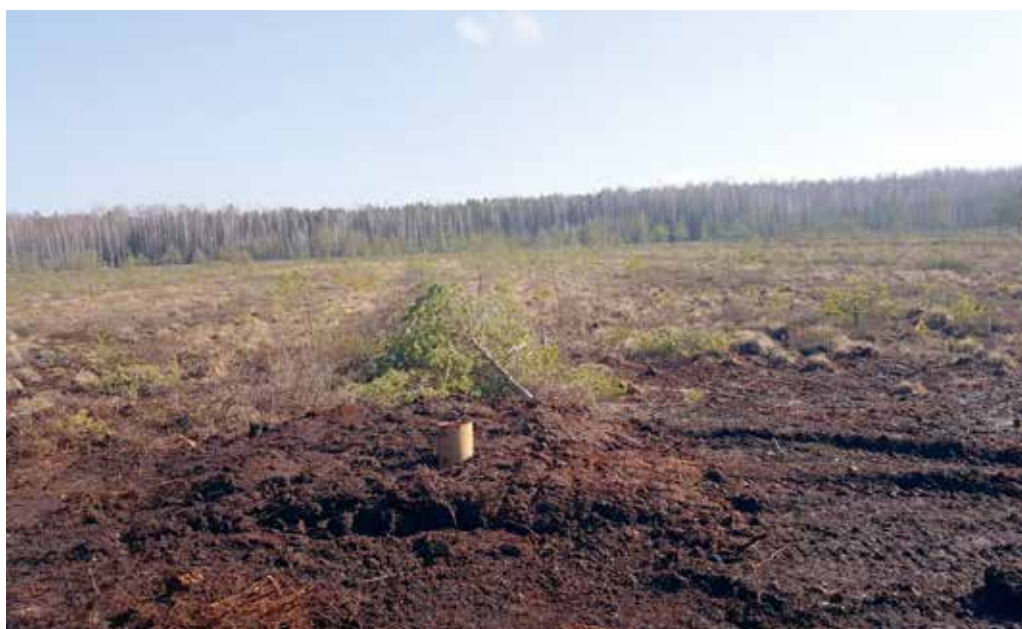
**Figure 161.** *A peat dam located at the place where the old drainage pipe was broken, March 2020. Photo: L. Jarašius.*

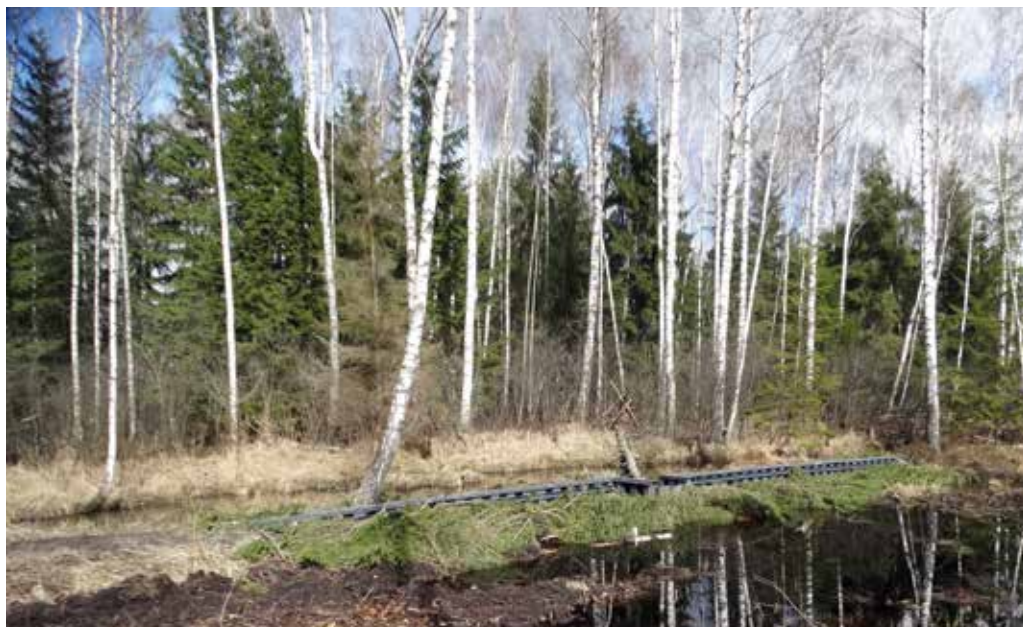
**Figure 162.** *Plastic pile sheet dams were installed in particularly wet and difficult to access places, March 2020. Photo: J. Sendžikaitė.*

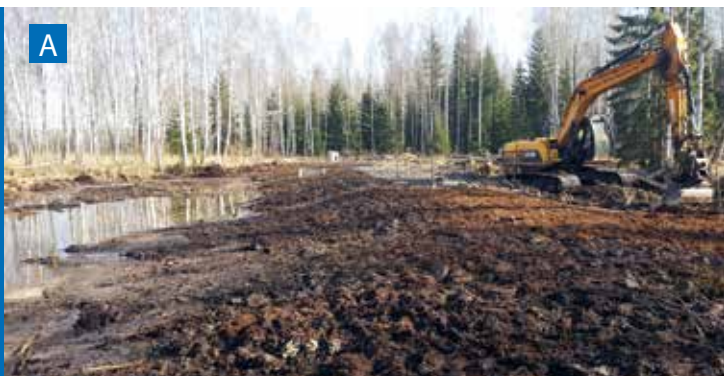
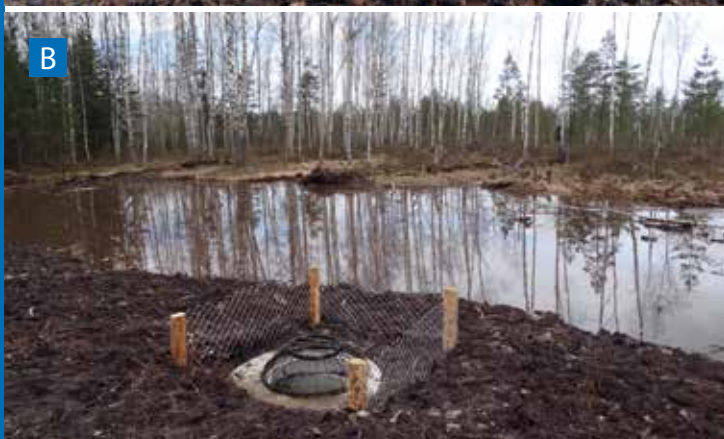
**Figure 163.**  
*Installation of water outflow embankment (A) with a water outflow construction (B) in Sachara peatland, March 2020. Photo: L. Jarašius.*

difficult to access places, plastic pile sheet dams were installed (Figure 162). The width of these dams varied from 4 to 16 metres. In addition, three special embankments supported by water outflow constructions were built at the edges of collective ditches (Figure 163). For the dam instalment and breaking the old drainage system, the same technique as in Pūsčia and Amalva was applied.

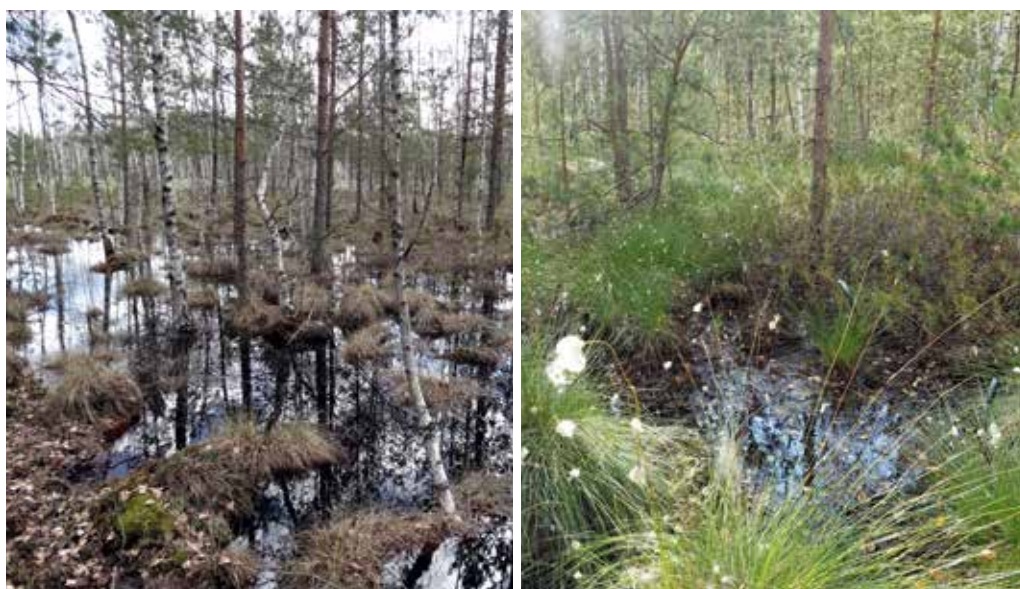
**Figure 165.** The rise of water level was noticed soon after the implementation of restoration measures (March 2020) and even during the active vegetation period, July 2021. Photos: J. Sendžikaitė.

Hydrological monitoring shows a positive effect of implemented restoration actions – installation of dams combined with tree removal. The average water level in 2020 (after rewetting) increased in all measurement points by 12–40 cm, compared to the period of 2018–2019 (before rewetting). Moreover, a decrease in water level fluctuations was noticed in all measurement points during 2020 (Figure 164). In some piezometers (S1, S2, S3), the difference between the maximum and minimum water levels (amplitude) decreased more than twice, which indicates the peatland's capacity to retain water even in the dry season. The highest water level was recorded in piezometer S2 characterized by the GEST “Moist forests and shrubberies” (Figures 165–167).

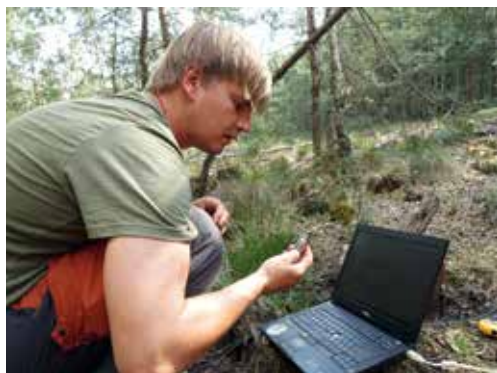
**Figure 166.** Hydrological monitoring shows positive effects of the restoration measures, July 2021.  
Photo: J. Sendžikaitė.

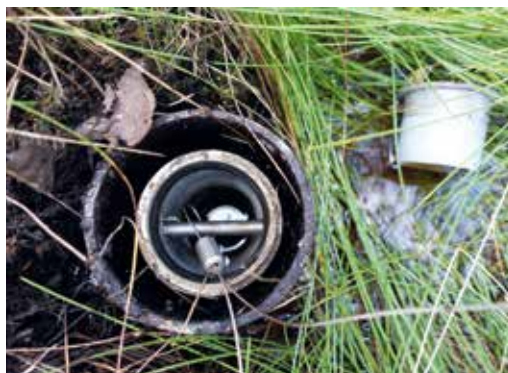
**Figure 167.** High water level was observed in the monitoring wells even in the middle of July 2021.  
Photo: J. Sendžikaitė.

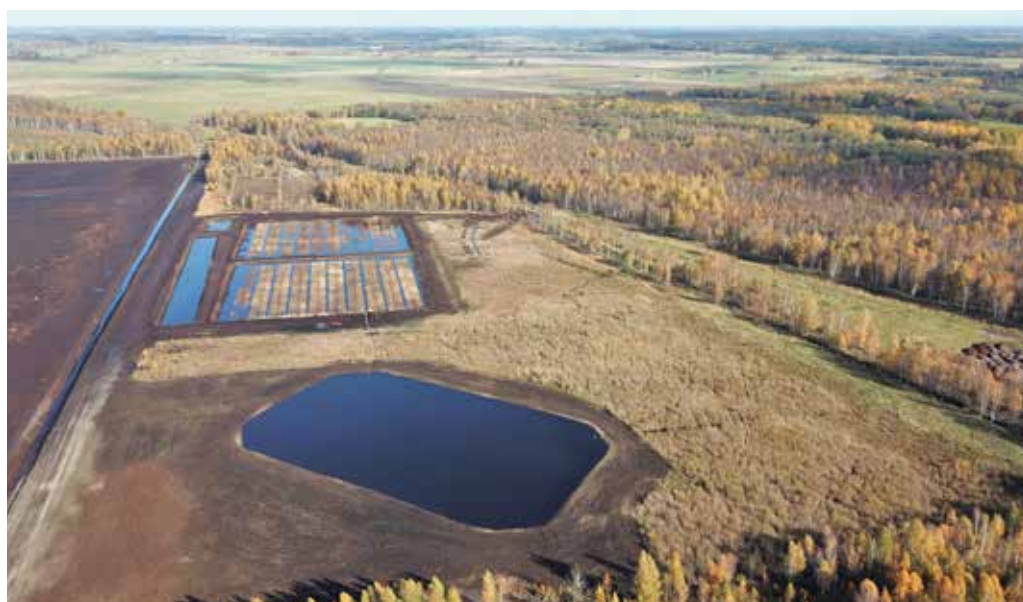
**Figure 168.** *The experimental field for the reintroduction of Sphagnum and other peat-forming vegetation in Aukštumala peatland, 2020. Photo: N. Zableckis.*

The LIFE Peat Restore project site (10 ha) is located at the north-eastern margin of the peat harvesting fields still in operation (Figure 168). Peat harvesting in the LIFE Peat Restore project site was completed almost 20 years ago, as the peat deposits are almost depleted. The residual peat layer varied from 0.05 to 2.25 metres. Before restoration, the site had unfavourable hydrological conditions (deep drainage), increased decomposition of the upper peat layer and vegetation typical for heavily drained bogs. In addition, there was an increased risk of fire incidents during the dry seasons.

The restoration actions were agreed with the peat extraction company operating in Aukštumala. The technical measures included reshaping of the site, installing irrigation systems (Figures 168, 170, 171A), setting water sources and supply, providing electric power, constructing the embankments, spreading diaspores of *Sphagnum* and other peat-forming vegetation, and maintenance of the field. The experimental area covering 2 ha was divided into two parts (1 ha in size each), irrigated by ditches installed at every 10 metres. Therefore, the area was levelled and the embankments installed (Figure 168).

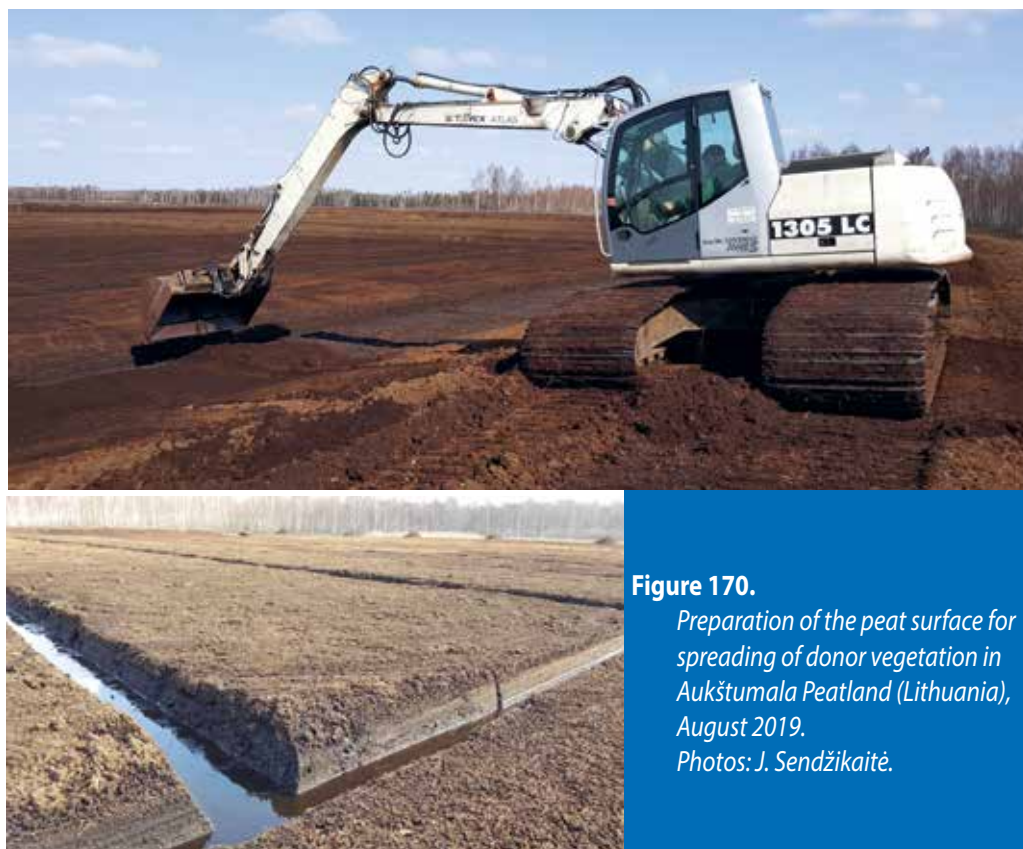
**Figure 170.**

*Preparation of the peat surface for spreading of donor vegetation in Aukštumala Peatland (Lithuania), August 2019.*

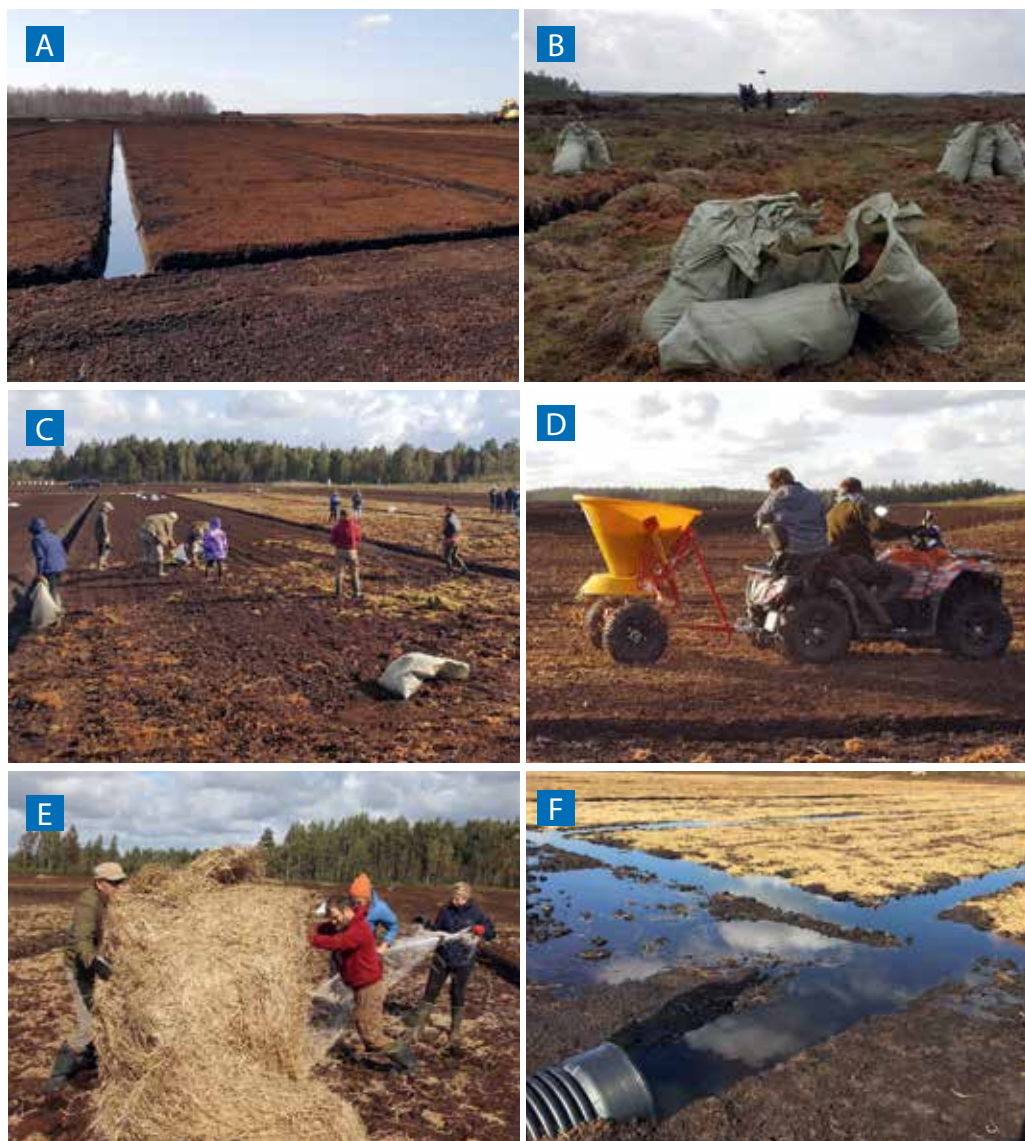
**Figure 171.** Reintroduction of peat-forming vegetation on peat fields in Aukštumala peatland, Lithuania: A – levelling of peat surface (April 2019), B – collection of donor material; (C) manual and (D) mechanized application of the donor material; E – straw mulching; F – flooded field covered with straw mulch (September 2019).  
Photos: J. Sendžikaitė, L. Šveistytė, Klasmann-Deilmann Šilutė.
